Residential Inspection Report

123 Everywhere St.

Anyplace , USA 55555

Inspection Date Mon, Nov 2 2015 at 11:00 AM

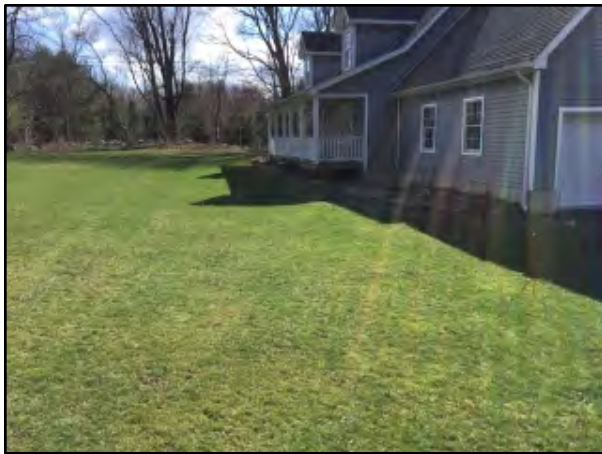
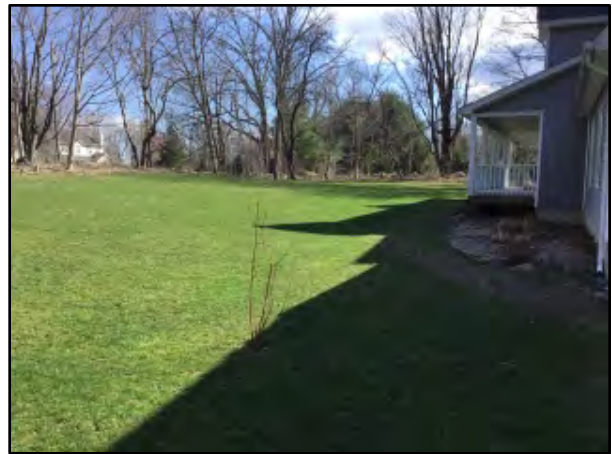
The property appears to be graded properly to allow rain water and melting snow to divert away from the structure when there is a normal amount of precipitation. Recommend monitoring areas around the foundation within 6' for ruts and depressions where areas of water can collect and pool.

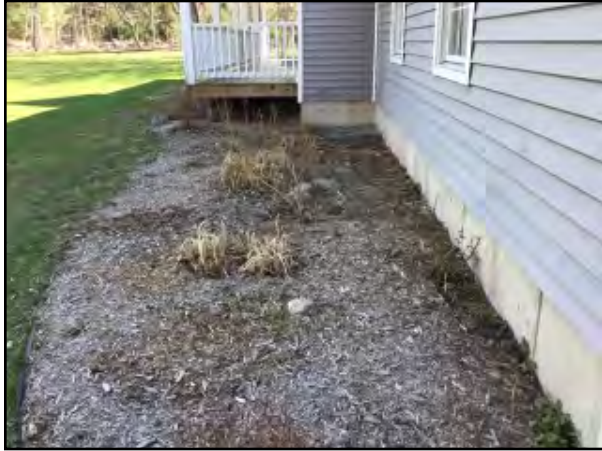
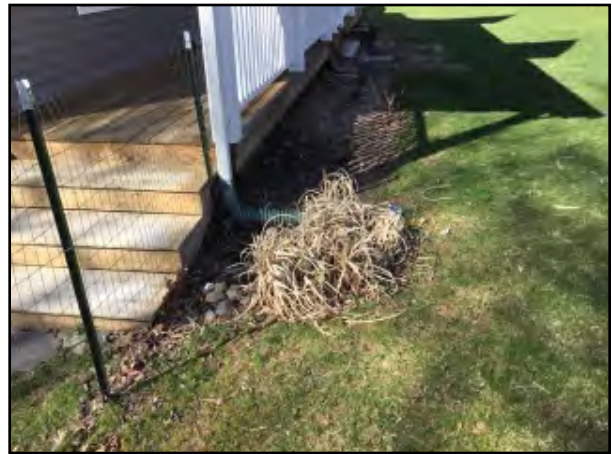
Shrub and tree growth are far enough away from the siding of the house. Regular maintenance and pruning should be done on an ongoing basis to prevent contact in the future which could lead to wood rot and unwanted moisture contacting the siding of the house.

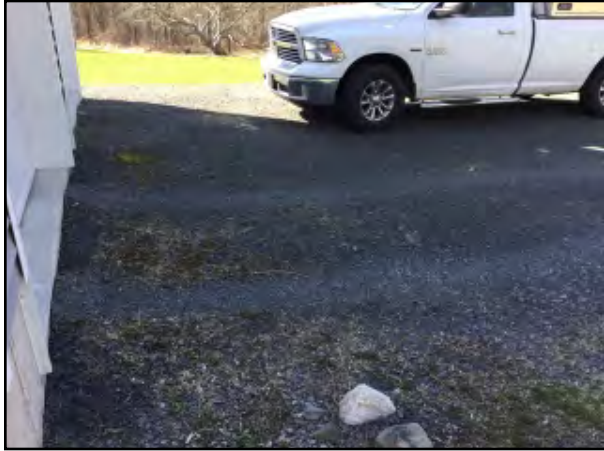
Figure 12-1

The gravel driveway is in good condition. No defects were noted and it is recommended to keep at least 2"-4" of gravel down at all times so ruts and depressions do not form.

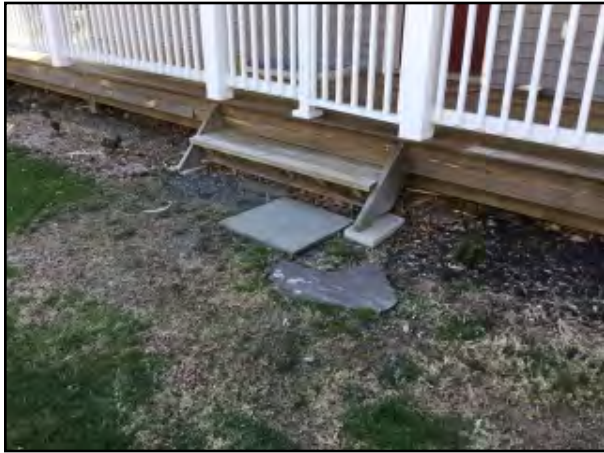
Figure 13-1

The front steps are in good condition with no major defects. Salt and snow melting materials are the largest contributor to surface deterioration.

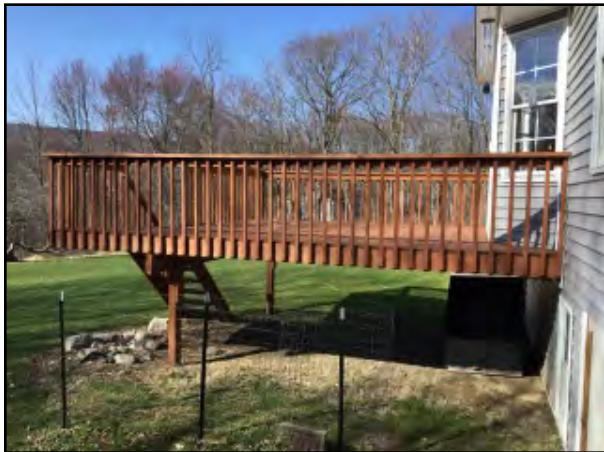
Figure 14-1

The deck is in good condition (except as noted below). As with any wood exposed to the weather, it is important to properly weather-seal it to prevent deterioration, cracking and rotting.

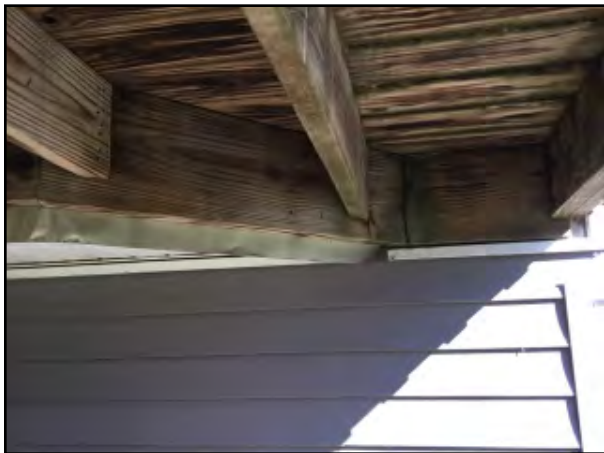
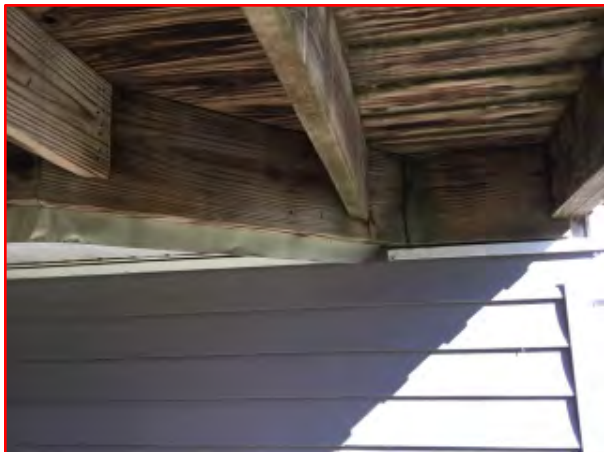
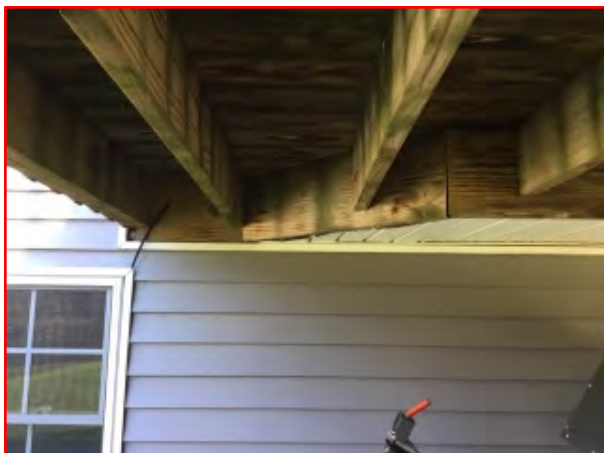
Figure 15-1

There are no bolts or joist hangers on the deck. Recommend hiring a qualified contractor to assess and repair.

1) There are no bolts or joist hangers on the deck. Recommend hiring a qualified contractor to assess and repair.

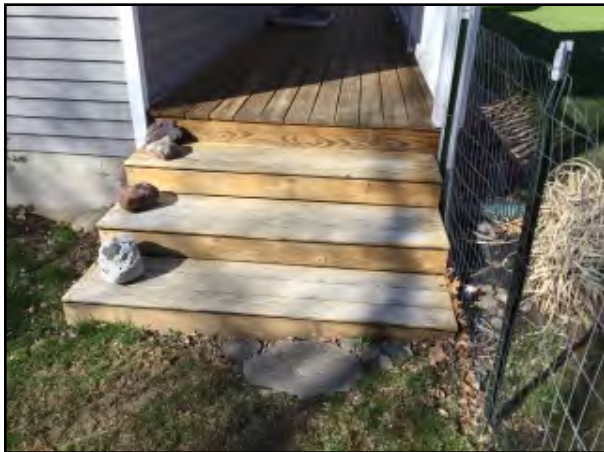
Figure 16-1

The front farmers porch is in good condition with no loose or rotted boards. The hand and guard rails are proper with correct spacing between the balusters. Recommend regular power washing and painting or staining to preserve the wood.

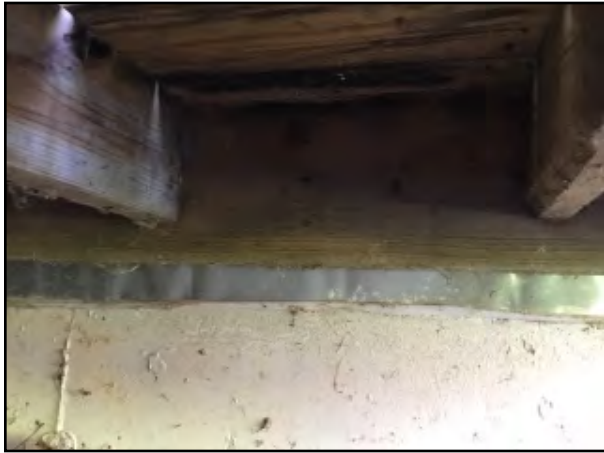
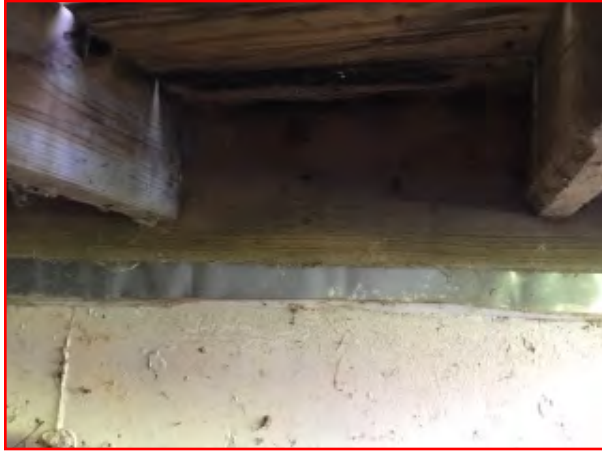
Figure 17-1

There are no bolts or joist hangers on the front porch. Recommend hiring a qualified contractor to assess and repair.

2) There are no bolts or joist hangers on the front porch. Recommend hiring a qualified contractor to assess and repair.

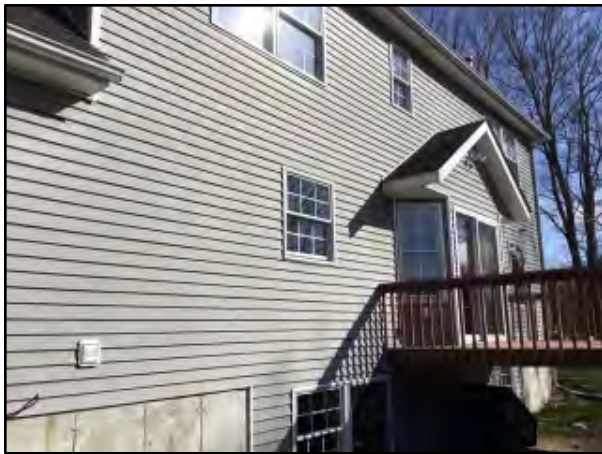
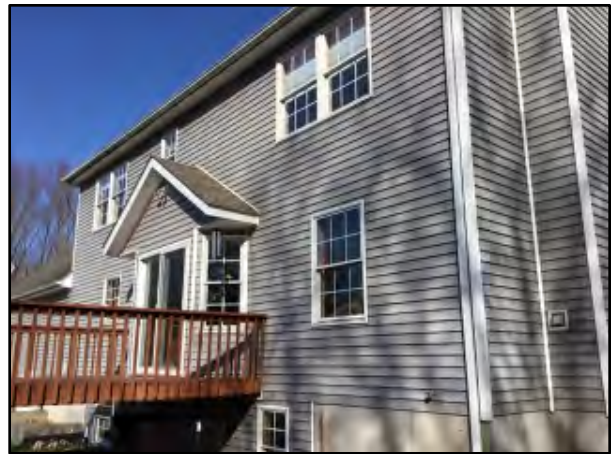
The exterior siding of the house is maintenance free vinyl and in good condition with no defects noted. Recommend regular cleaning and power washing to keep the siding in good condition.

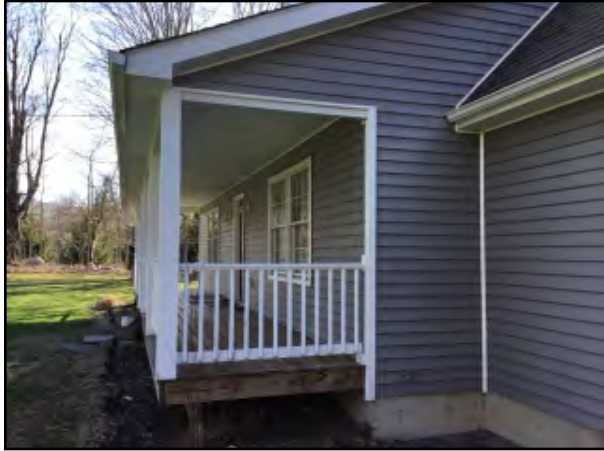
Figure 19-1

The exterior trim of the house is maintenance free vinyl (except as noted below) and in good condition with no defects noted. Recommend regular cleaning and power washing to keep the siding in good condition.

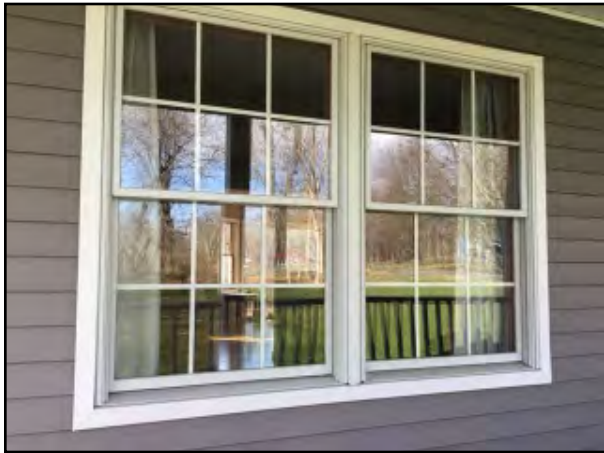
Figure 20-1

The windows are all maintenance-free wood/vinyl windows. No major defects were noted on the exterior on the day of inspection.

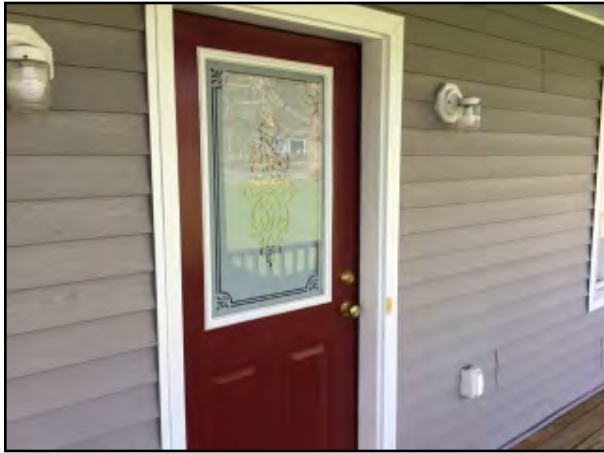
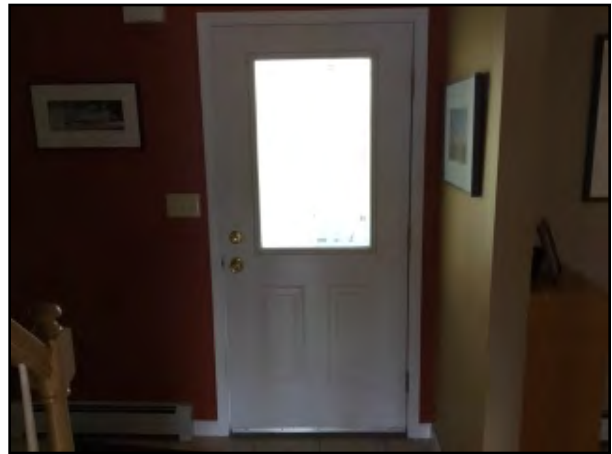
The front door is in good condition with no defects noted. Although not a defect, there was no combination screen and storm door and it is recommended to install one for energy efficiency purposes.

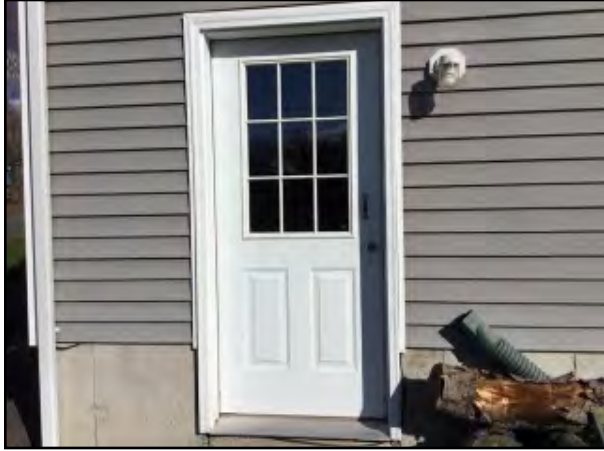
Figure 22-1

The side entry door is in good condition except as noted below.

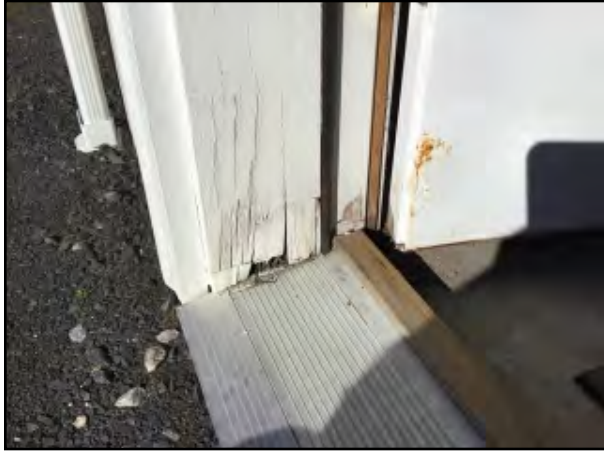
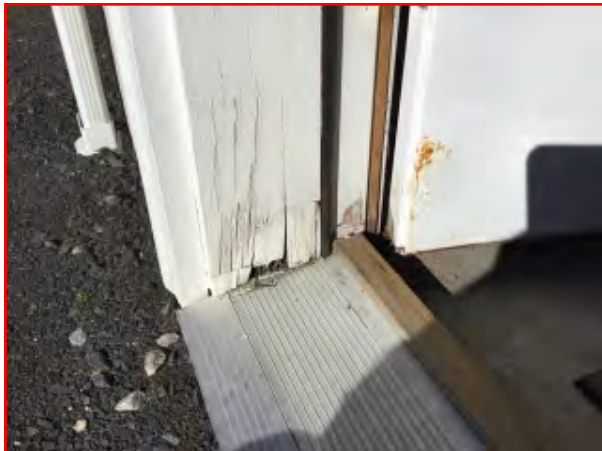
Figure 23-1

The side door jamb into the garage is starting to rot. Recommend hiring a qualified contractor to assess and repair any defects.

3) The side door jamb into the garage is starting to rot. Recommend hiring a qualified contractor to assess and repair any defects.

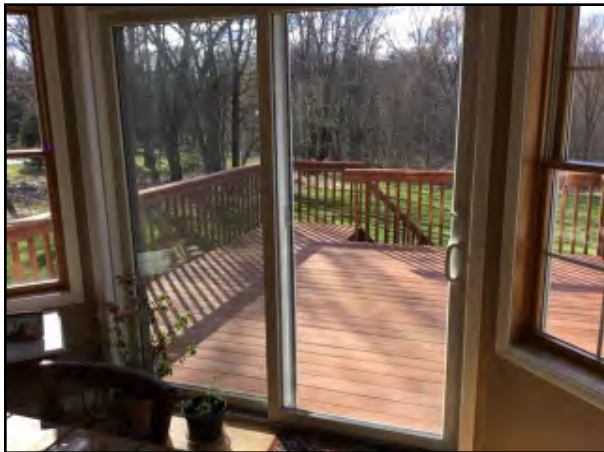
Figure 24-1

The sliding glass door is in good condition with no defects noted. The screen/storm door was operational and in working condition on the day of inspection.

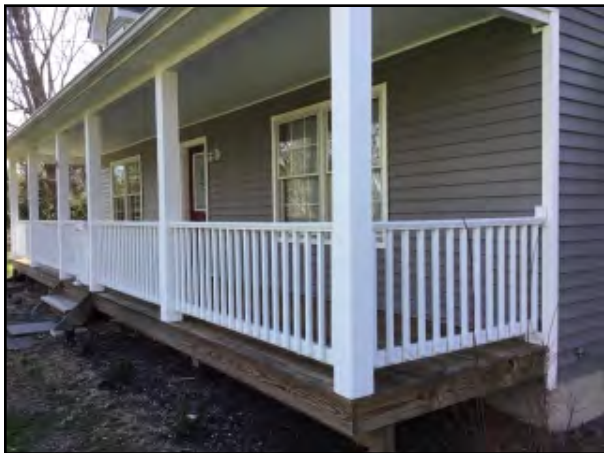
Figure 25-1

The porch columns and railings are painted wood in good condition. Recommend inspecting and maintaining all exterior wood to keep it in satisfactory condition.

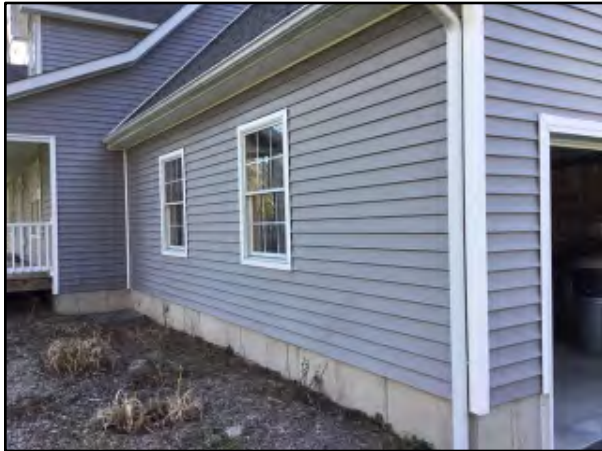
Figure 26-1

The exterior siding and trim of the garage is maintenance free vinyl and in good condition with no defects noted. Recommend regular cleaning and power washing to keep the siding in good condition.

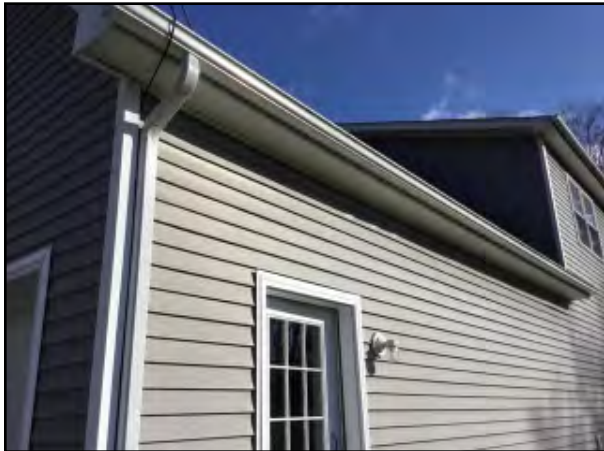
Figure 27-1

The exterior fascias and soffits of the garage are maintenance free aluminum and vinyl in good condition with no major defects noted.

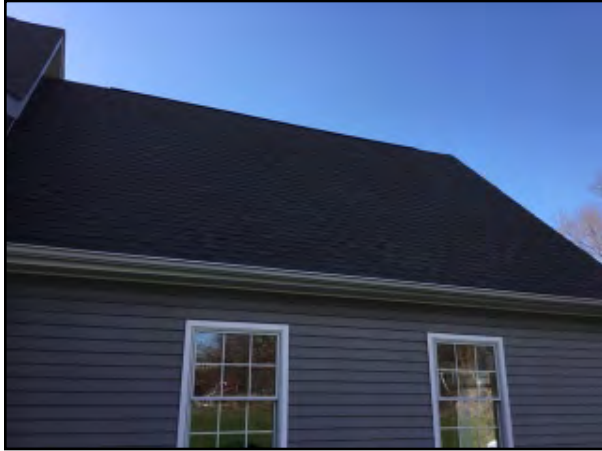
Figure 28-1

The garage roof is comprised of architectural asphalt shingles with no major defects noted. The roof is 12 years old and is rated for a 35 year life expectancy. Venting was proper with gable vents and doors/windows and no signs of moisture or water penetration were noted at the ceiling.

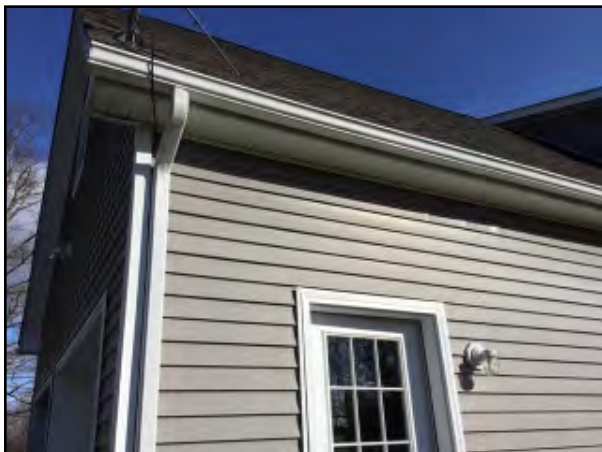
Figure 29-1

The gutters are aluminum and appear to be working properly to divert rain water away from the garage as there are no signs of excess moisture in the interior of the garage being caused by improper gutters. Recommend keeping gutters free and clear of debris and leaves.

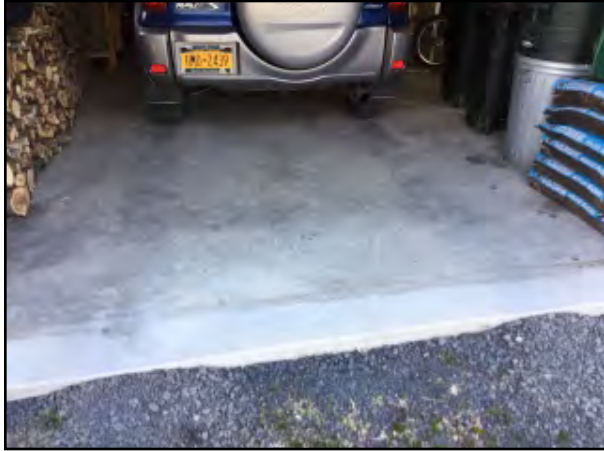
Figure 30-1

The garage is a traditional stick built building with 2x4/6 exterior walls and 2x6/8 roof rafters. The structure is in good condition with no apparent signs of moisture or water leaks at the roof. The concrete slab floor was in good condition with minor settling cracks and the garage doors are maintenance free aluminum with chain driven opener on one door only. The doors opened and closed properly and the auto reverse worked properly .

The walls and ceiling were sheet rocked/concrete for fire safety purposes where necessary, and the door leading to the interior was fire rated and self closing. No major defects were noted on the day of inspection.

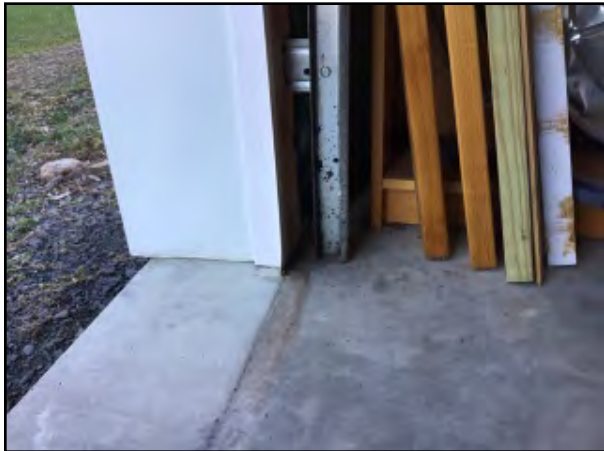
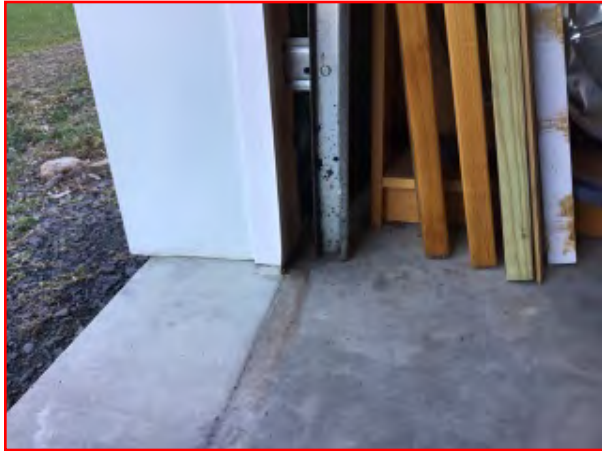
Figure 31-1

There is no photo eye attached to the garage door opener. As this is a safety issue we recommend hiring a qualified contractor to assess and repair any defects .

4) There is no photo eye attached to the garage door opener. As this is a safety issue we recommend hiring a qualified contractor to assess and repair any defects .

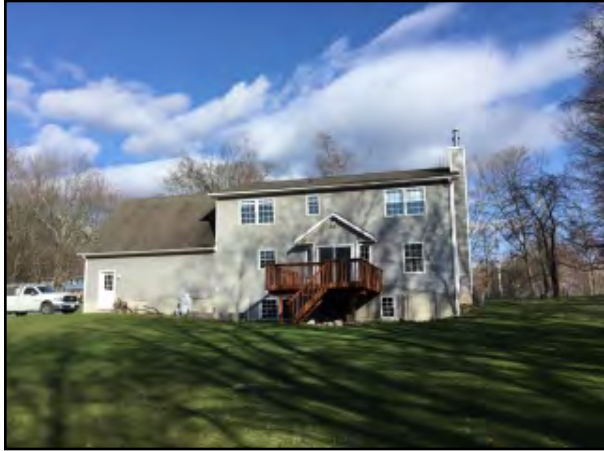
Figure 32-1

The roof is comprised of architectural asphalt shingles and is approximately 12 years old. These type shingles are rated for a 30 to 35 year life expectancy depending on weather conditions, climate and other factors. Venting was proper with ridge and soffit vents, and the plumbing stacks were noted and at an adequate height above the roof line.

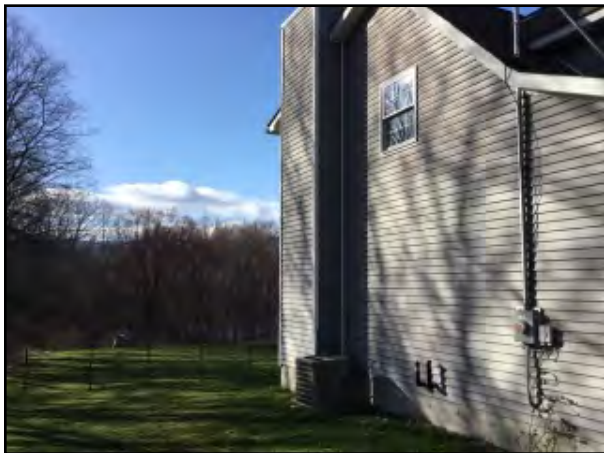
Figure 33-1

The chimney is wood framed and in good condition. There is a proper spark arrestor and rain cap on the top of the chimney and no major defects were noted.

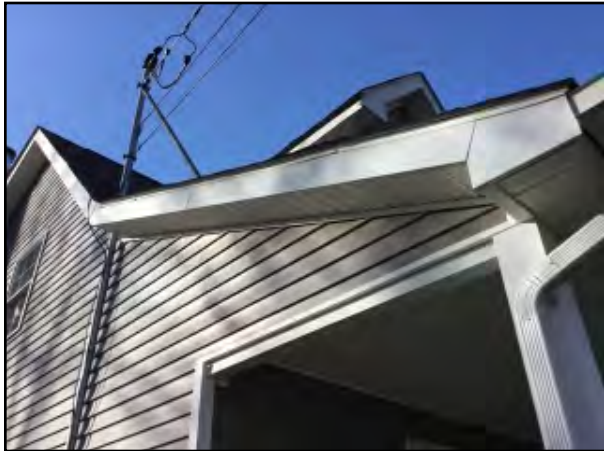
Figure 34-1

The fascias and soffits are comprised of maintenance-free vinyl and aluminum and are in adequate condition. It is important to immediately repair any soffit or fascia materials that may become loose or dislodged to prevent water and ice from getting behind these surfaces and causing damage to any wood products.

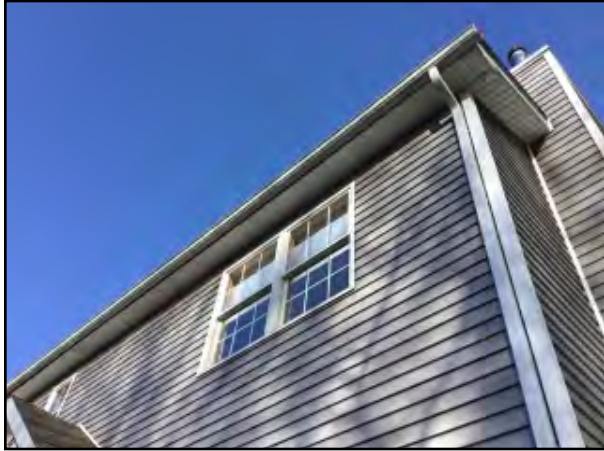
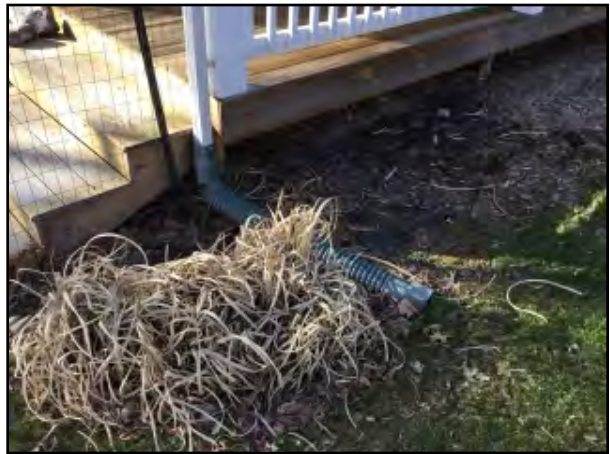
The gutters are aluminum and appear to be working properly to divert rain water away from the house as there are no signs of excess moisture in the basement/crawlspace being caused by improper gutters, and no gulleyes were present in the ground next to the foundation walls (see interior basement/crawlspace notes for further comments). Recommend keeping gutters free and clear of debris and leaves and that gutter extensions are at least 6' from the foundation. Also watch the areas where the gutters go to an underground drainage system (if applicable) for water backing up. If this occurs it is recommended to have the underground lines scoped and snaked if necessary.

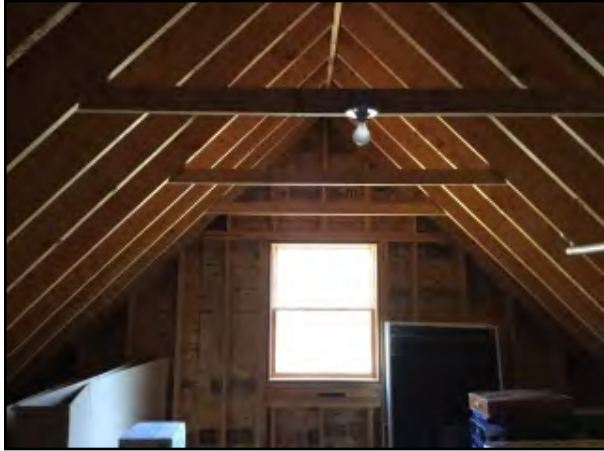
Figure 37-1

The attic was in good condition with no leaks or signs of moisture or mold. The attic was fully insulated and appeared to be properly ventilated with a combination of ridge and soffit vents.

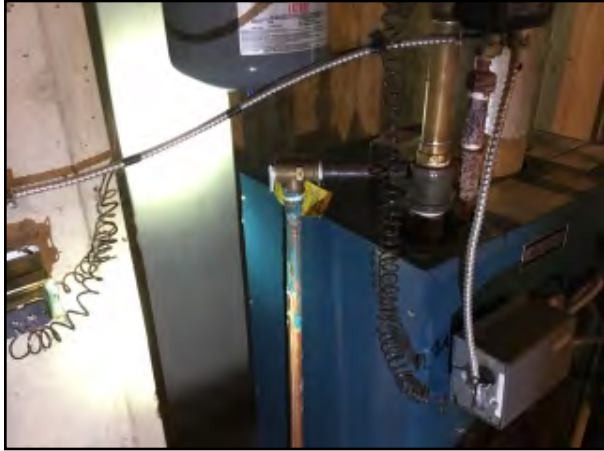
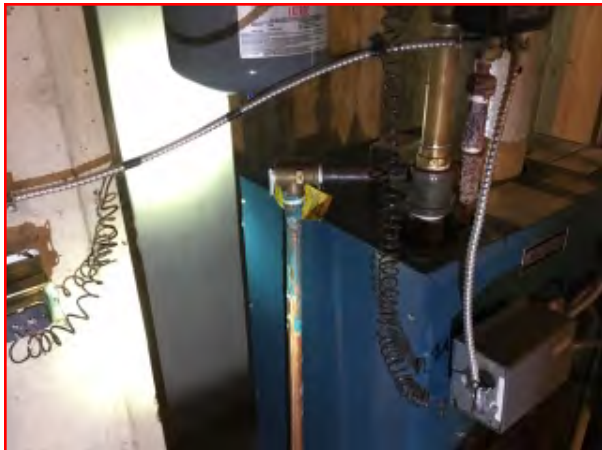
Figure 40-1

The TPRV valve was leaking and corroded. Recommend hiring a qualified contractor to assess and repair.

5) The TPRV valve was leaking and corroded. Recommend hiring a qualified contractor to assess and repair.

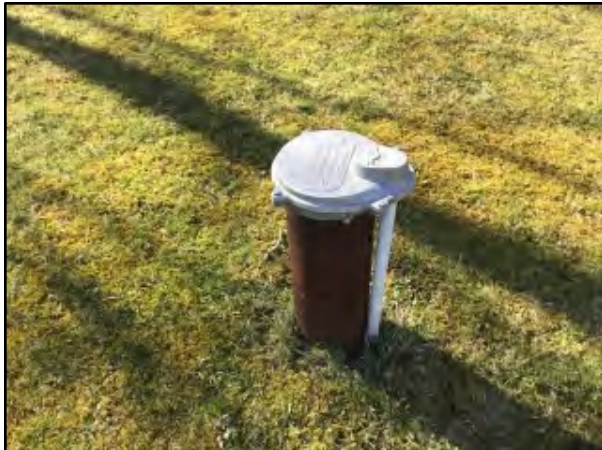
Figure 41-1

The plumbing system of the house consisted of a private well and septic system. The water was run through all fixtures in the home for 30 minutes and there were no leaks noted on the supply or drain sides and the well components were tested and operated as intended. The well pump cycled normally and psi was between 30-40 while cycling. The well tank is approximately 12 years old and no major defects were noted. There is an extensive water treatment system tied into the plumbing. Recommend speaking with the owner about operation and maintenance.

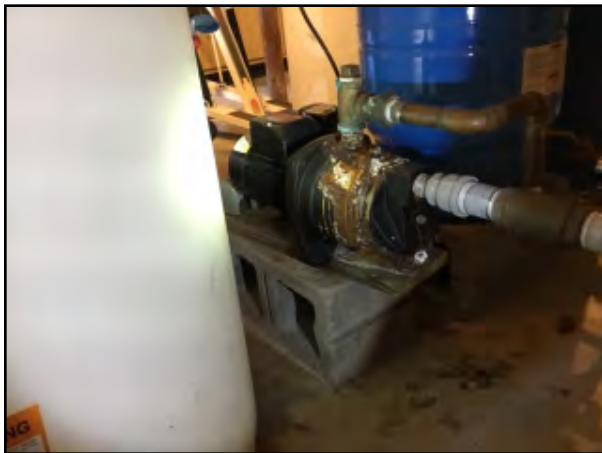
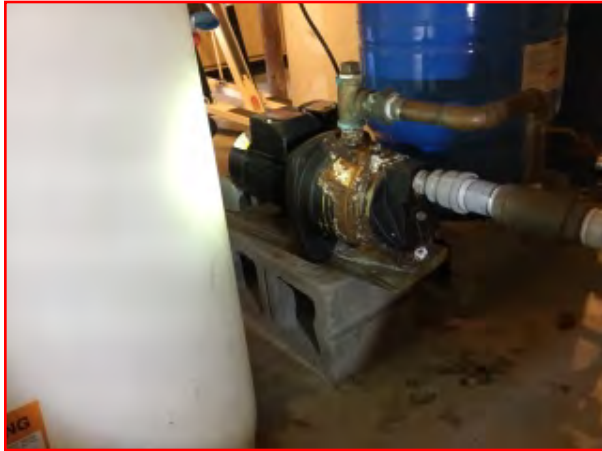
Figure 42-1

The jet pump on the water system was corroded and leaking. Recommend hiring a qualified contractor to assess and repair any defects.

6) The jet pump on the water system was corroded and leaking. Recommend hiring a qualified contractor to assess and repair any defects.

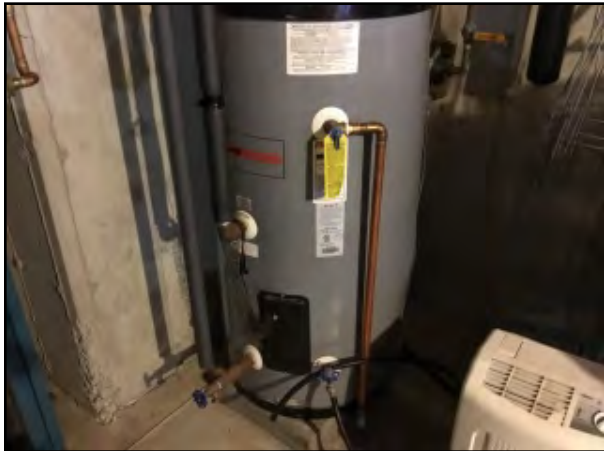
Figure 43-1

The water heater is a 50 gallon indirect heated Superstor tank located in the basement which operated properly on the date of inspection. The tank showed no signs of rust or corrosion. Hot water was received at all sinks and tubs in the home.

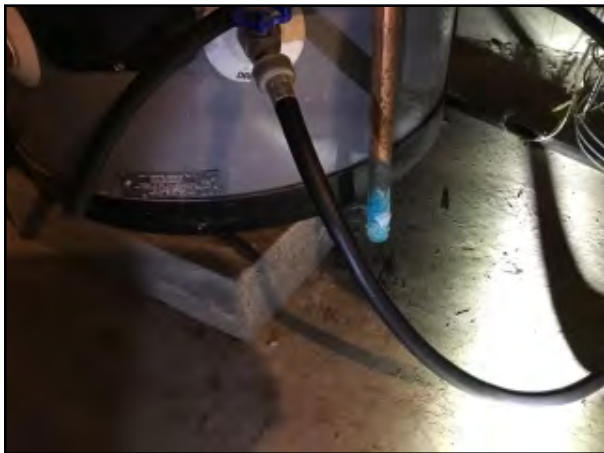
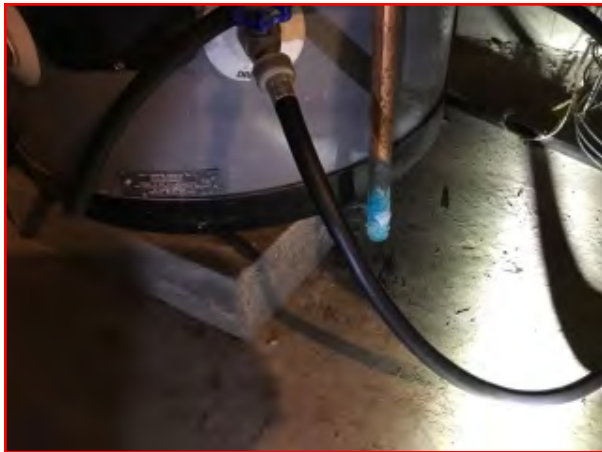
Figure 44-1

The tprv valve on the water heater was leaking and should be replaced. Recommend hiring a qualified contractor to assess and repair.

7) The tprv valve on the water heater was leaking and should be replaced. Recommend hiring a qualified contractor to assess and repair.

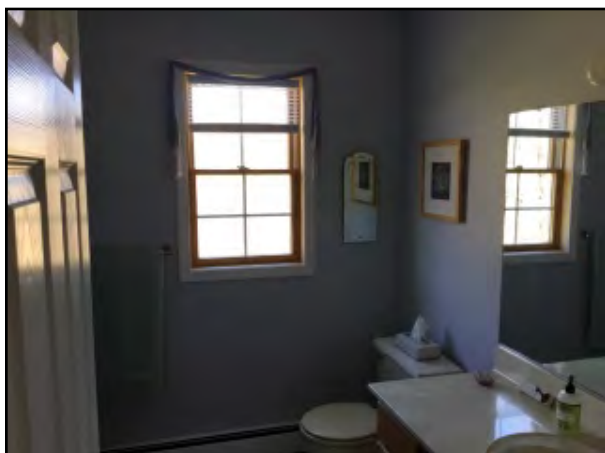
Figure 46-1

The main bath was in working condition with no leaks noted at the sink, toilet or tub/shower. The GFCI outlet was tested and operated properly on the date of inspection. There was a window and exhaust fan for ventilation and no mold or mildew was noted on the walls or ceiling.

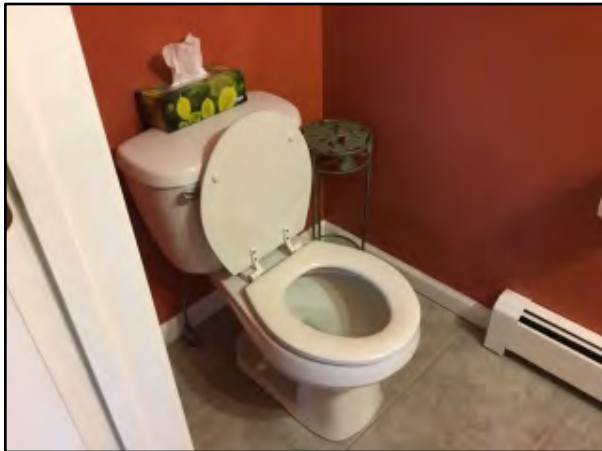
Figure 47-1

The 1/2 bath was in working condition with no leaks noted at the sink or toilet. There was an exhaust fan for ventilation and no excess moisture or mold was noted. The GFCI was tested and operated properly.

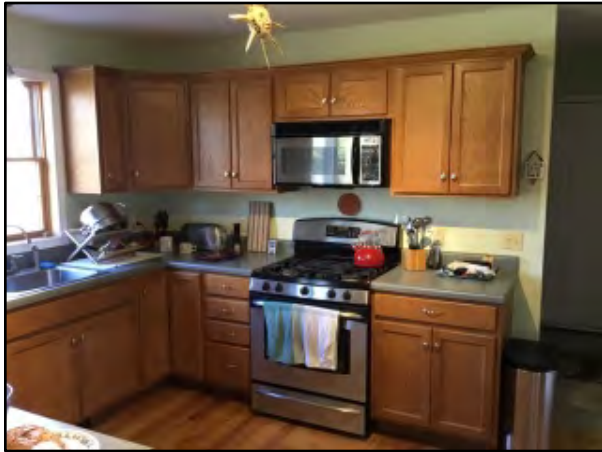
Figure 48-1

The kitchen was in working condition with no major defects noted. There were no leaks at the sink or dishwasher, and all the appliances were tested and operated properly on the date of inspection. All the cabinets and countertops were operational and secure. The range was vented by the microwave and GFCI outlets were tested and operated properly on the date of inspection.

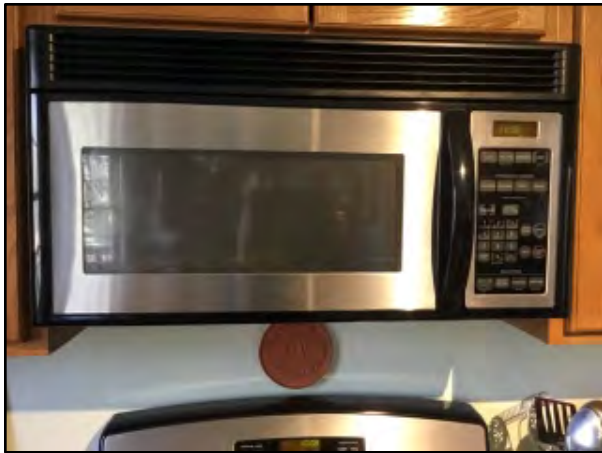
Figure 49-1

All the appliances were tested and were in working condition. The stove was vented by a range hood exhaust and operated properly. The sink is a single unit in good condition with no leaks noted.

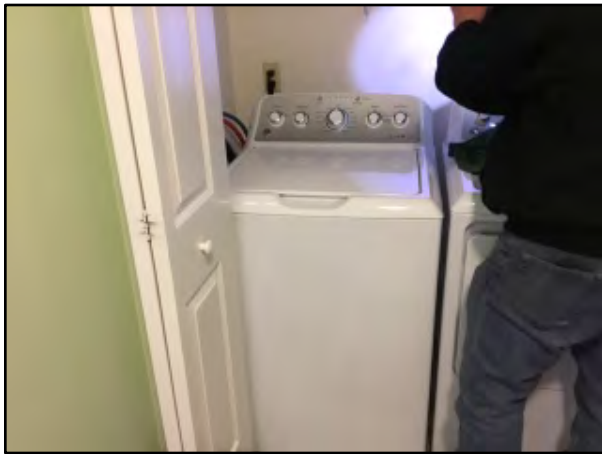
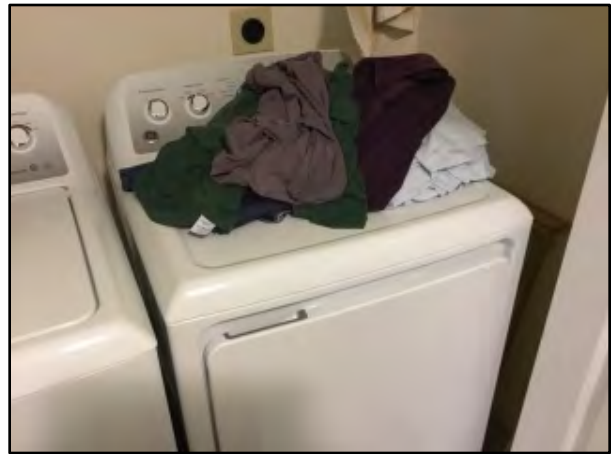
The laundry area was in acceptable condition with no major defects noted. There were no leaks at the washing machine connections and there was an exhaust hose present to vent the dryer properly to the exterior.

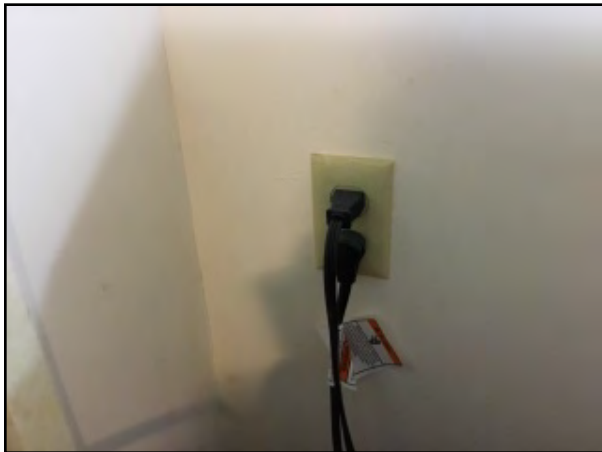
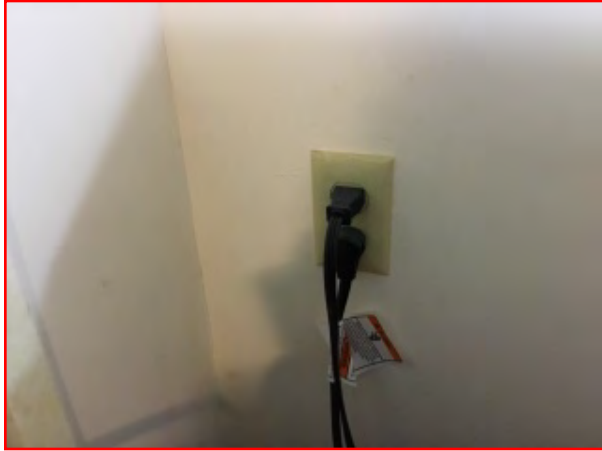
Figure 51-1

The outlet in the laundry area was not a GFCI outlet and is a safety hazard as it is directly below/next to the water supply lines. Recommend hiring a licensed electrician to replace the existing outlet with a GFCI outlet as necessary.

8) The outlet in the laundry area was not a GFCI outlet and is a safety hazard as it is directly below/next to the water supply lines. Recommend hiring a licensed electrician to replace the existing outlet with a GFCI outlet as necessary.

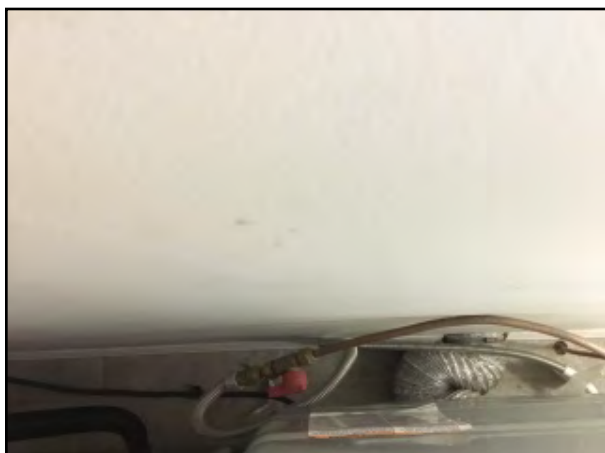
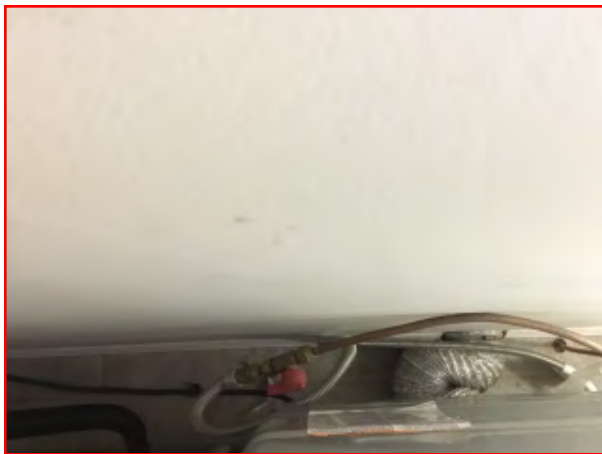
Figure 52-1

The exhaust hose for the dryer is a ribbed hose, not solid metal wall which is recommended for fire safety purposes. The current hose (ribbed wall) has a tendency to collect lint which is a fire hazard. Recommend hiring a qualified contractor to assess and repair as necessary.

9) The exhaust hose for the dryer is a ribbed hose, not solid metal wall which is recommended for fire safety purposes. The current hose (ribbed wall) has a tendency to collect lint which is a fire hazard. Recommend hiring a qualified contractor to assess and repair as necessary.

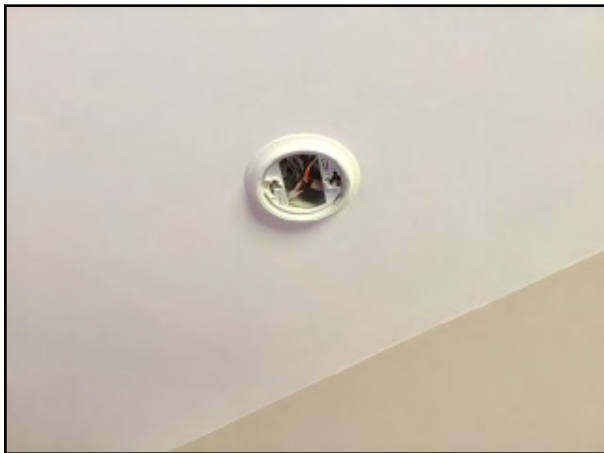
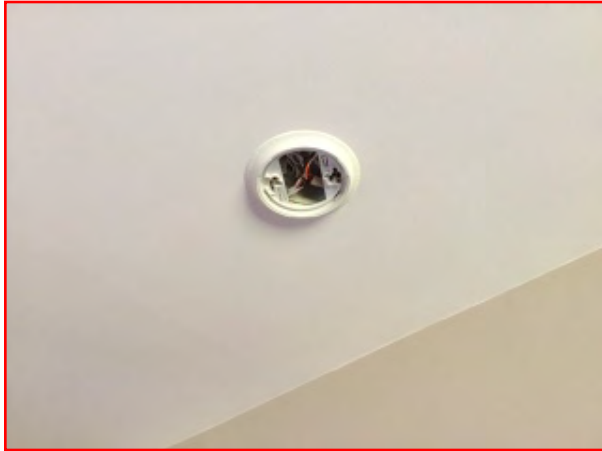
Figure 55-1

There are two bedrooms upstairs that have missing smoke alarms. As this is a safety issue it is recommended to replace them as soon as possible.

10) There are two bedrooms upstairs that have missing smoke alarms. As this is a safety issue it is recommended to replace them as soon as possible.
