Residential Inspection Report

123 Everywhere St.

Anyplace , USA 55555

Inspection Date Mon, Nov 2 2015 at 11:00 AM

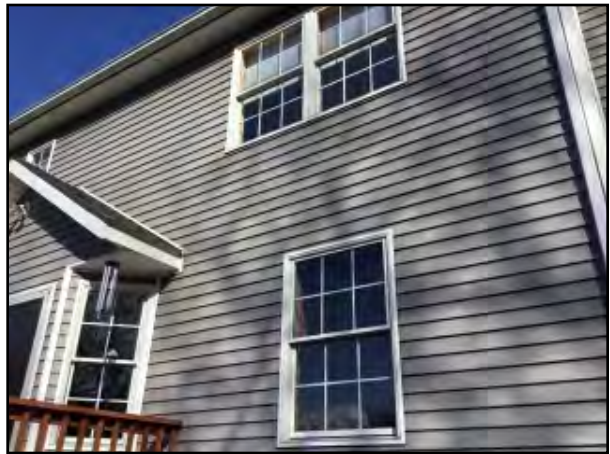
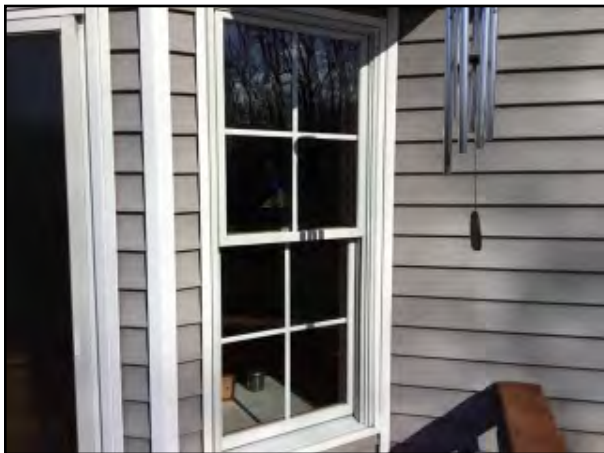
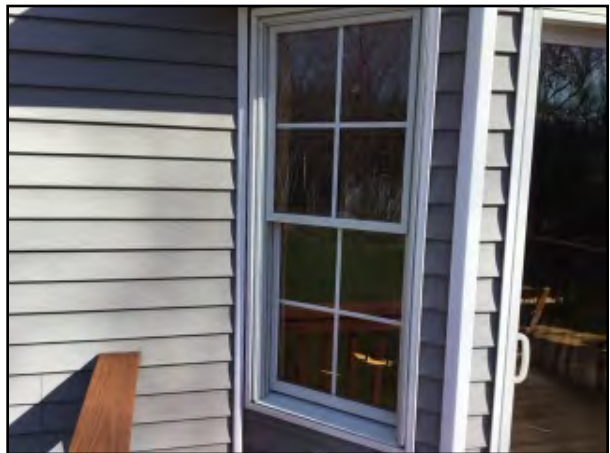
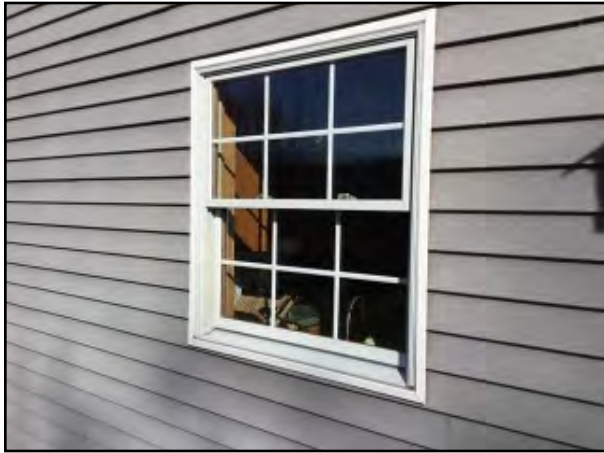
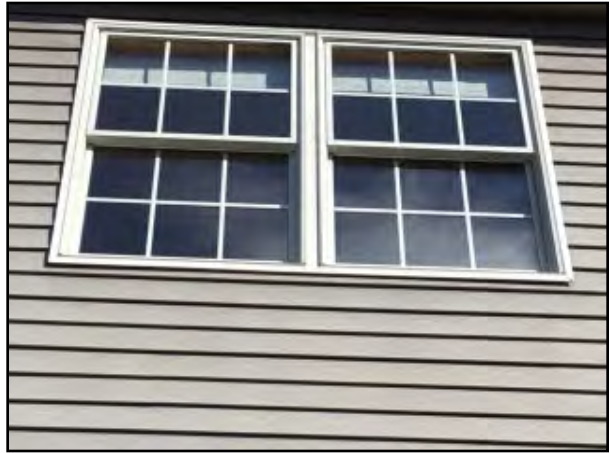
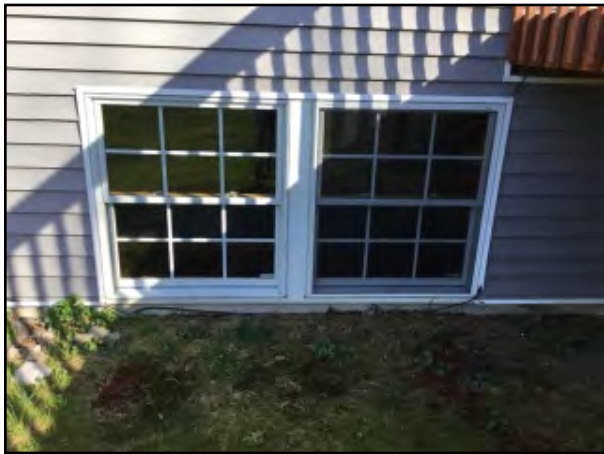
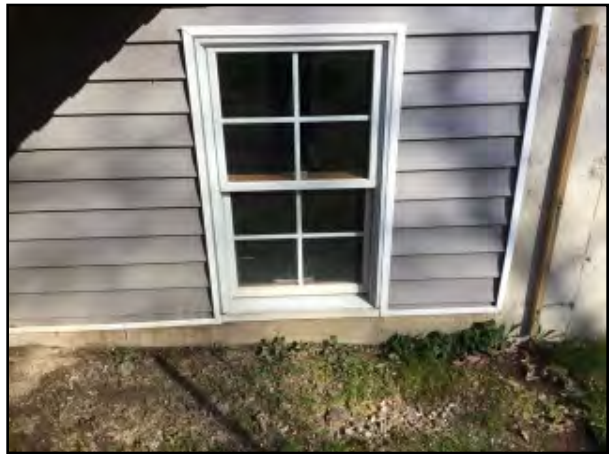
The windows are all maintenance-free wood/vinyl windows. No major defects were noted on the exterior on the day of inspection.

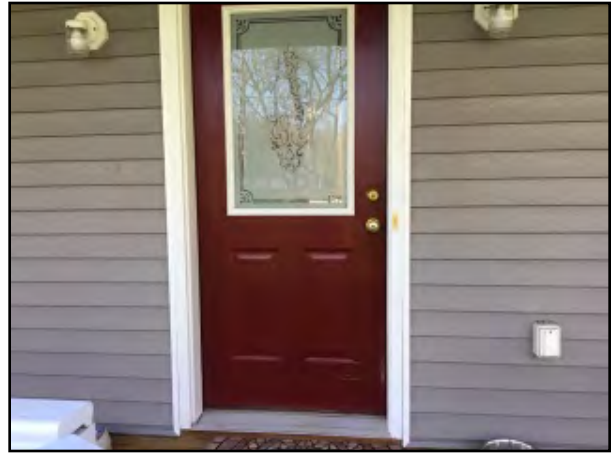
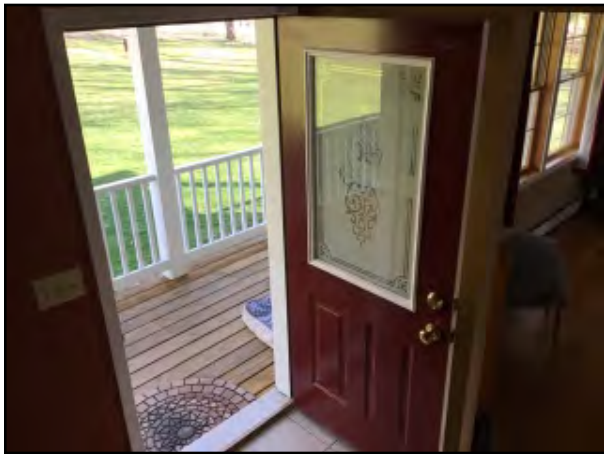
The front door is in good condition with no defects noted. Although not a defect, there was no combination screen and storm door and it is recommended to install one for energy efficiency purposes.

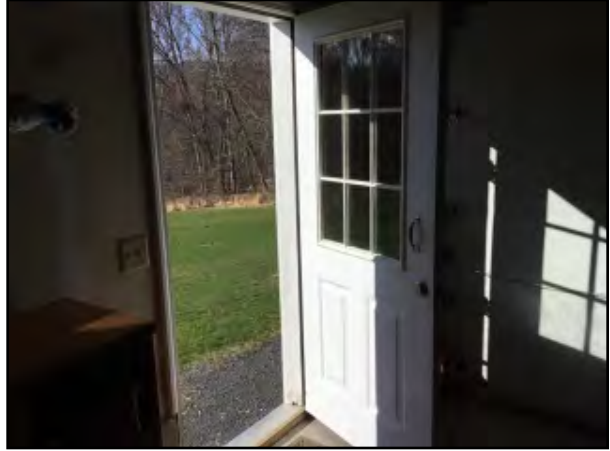
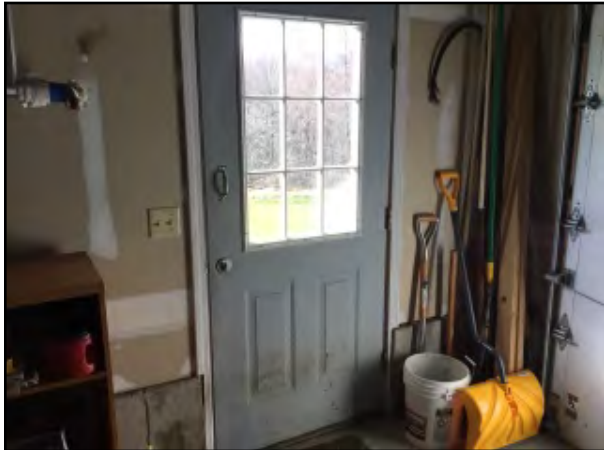
The side entry door is in good condition except as noted below.

The side door jamb into the garage is starting to rot. Recommend hiring a qualified contractor to assess and repair any defects.

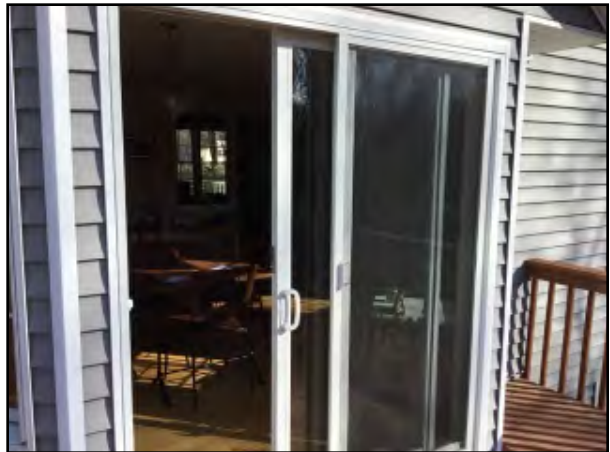
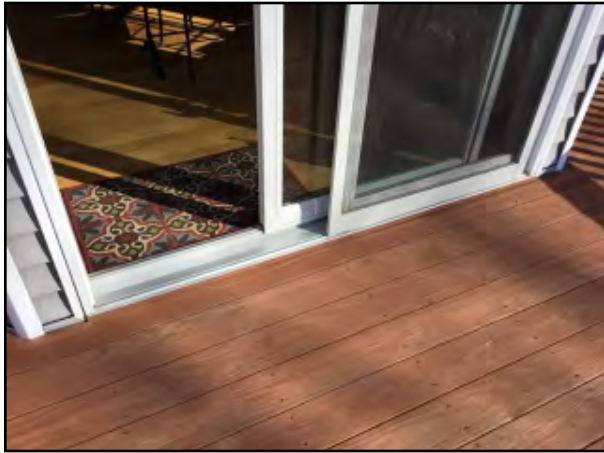
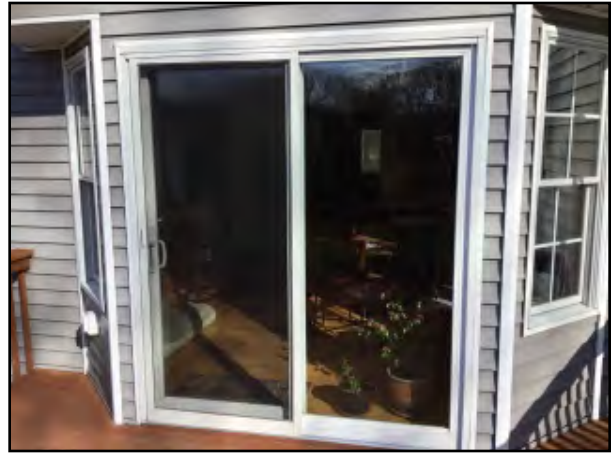
The sliding glass door is in good condition with no defects noted. The screen/storm door was operational and in working condition on the day of inspection.

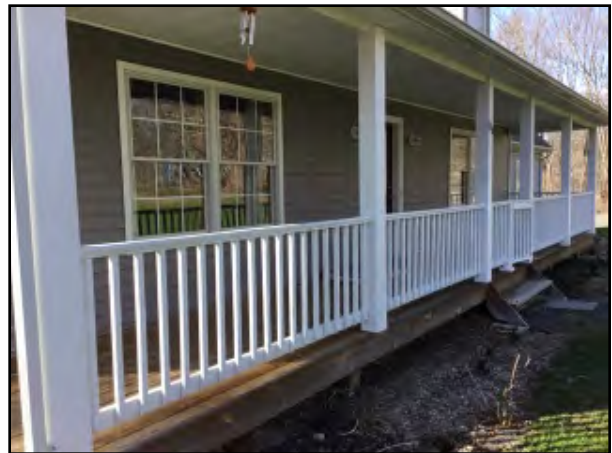
Figure 25-2

The porch columns and railings are painted wood in good condition. Recommend inspecting and maintaining all exterior wood to keep it in satisfactory condition.

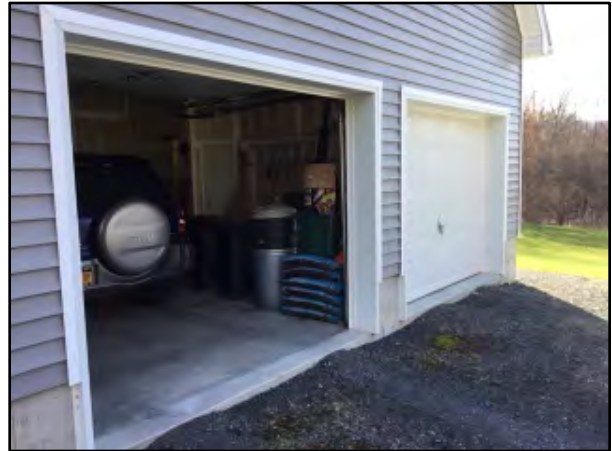
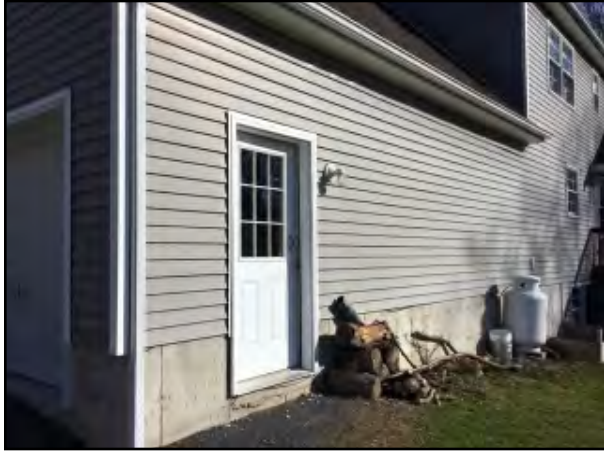
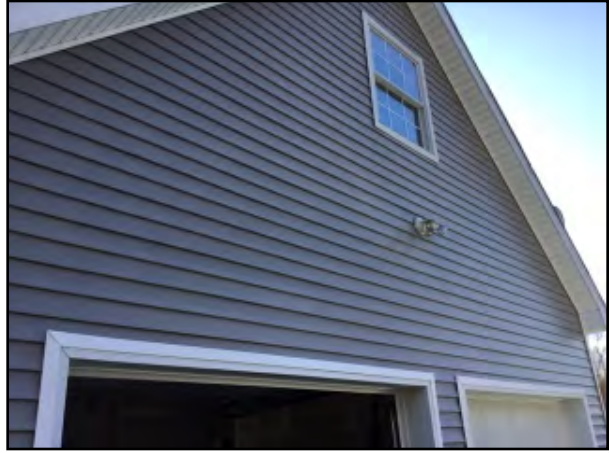
The exterior siding and trim of the garage is maintenance free vinyl and in good condition with no defects noted. Recommend regular cleaning and power washing to keep the siding in good condition.

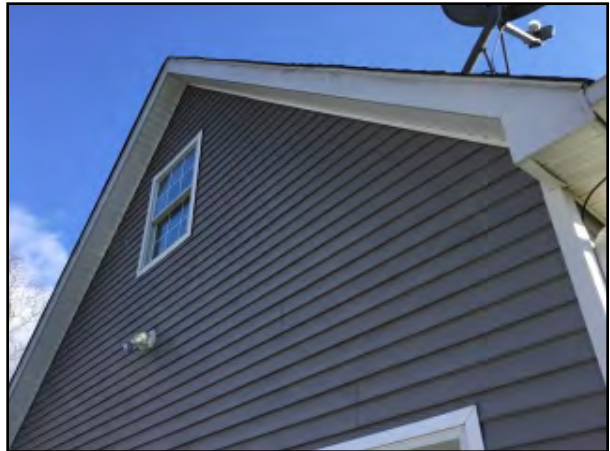
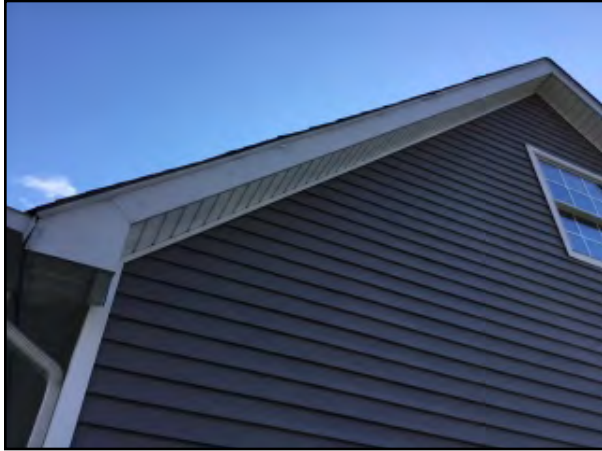
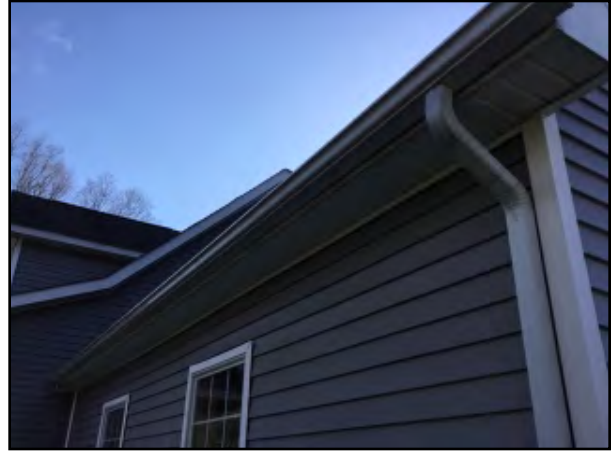
The exterior fascias and soffits of the garage are maintenance free aluminum and vinyl in good condition with no major defects noted.

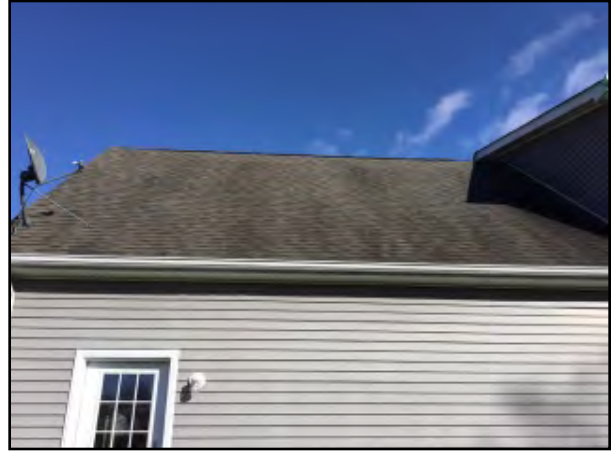
Figure 28-2

The garage roof is comprised of architectural asphalt shingles with no major defects noted. The roof is 12 years old and is rated for a 35 year life expectancy. Venting was proper with gable vents and doors/windows and no signs of moisture or water penetration were noted at the ceiling.

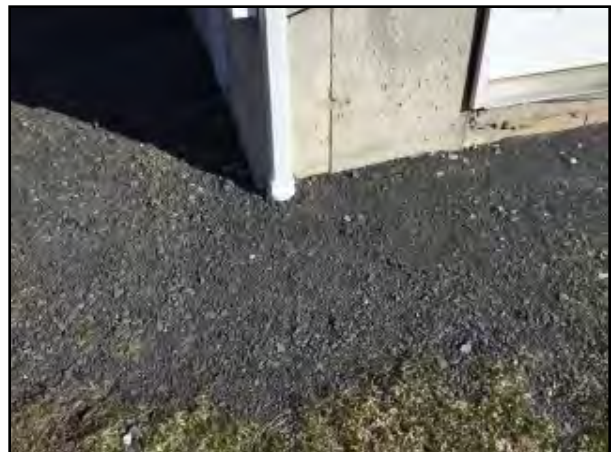
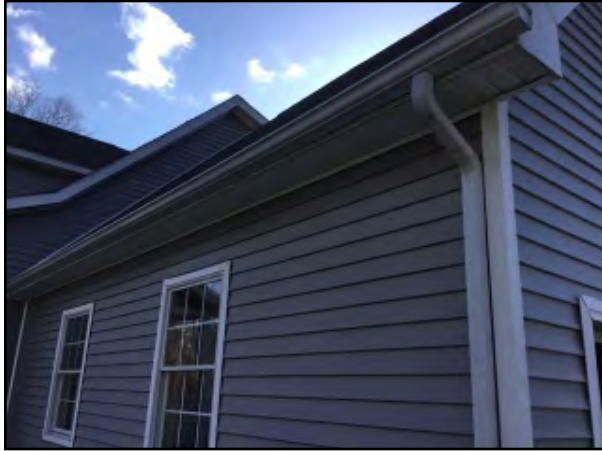
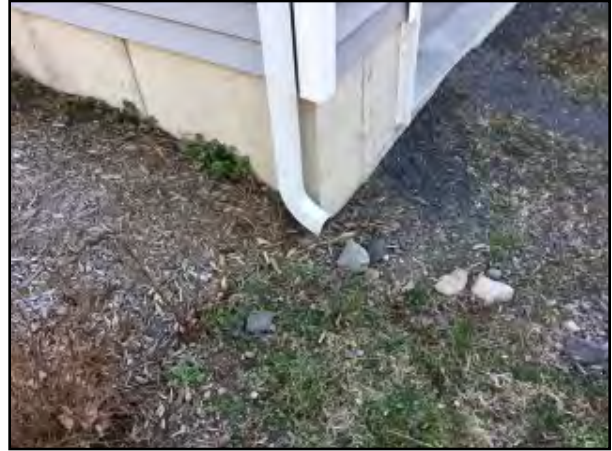
The gutters are aluminum and appear to be working properly to divert rain water away from the garage as there are no signs of excess moisture in the interior of the garage being caused by improper gutters. Recommend keeping gutters free and clear of debris and leaves.

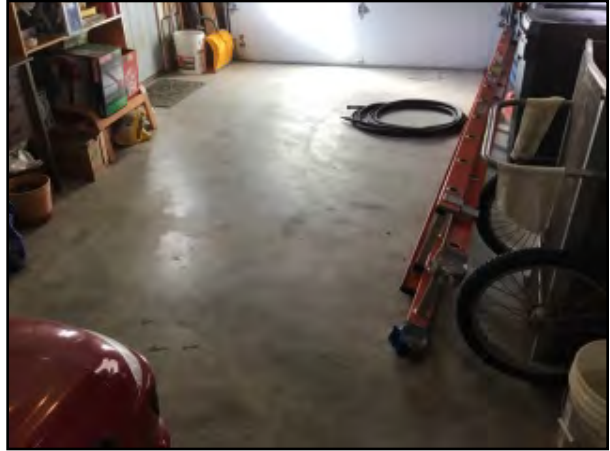
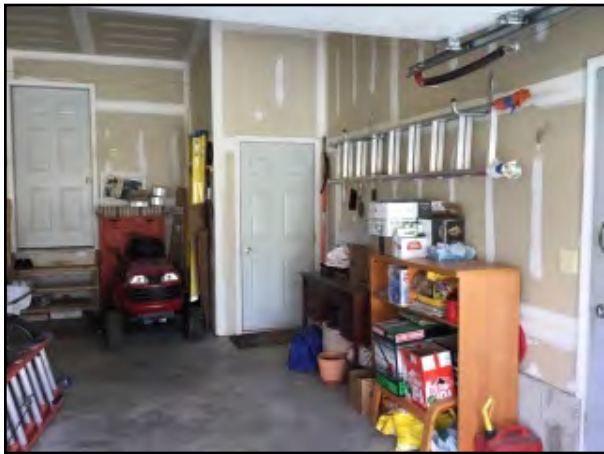
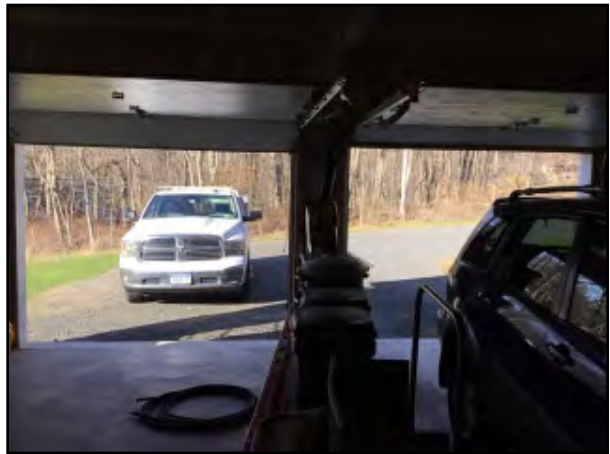
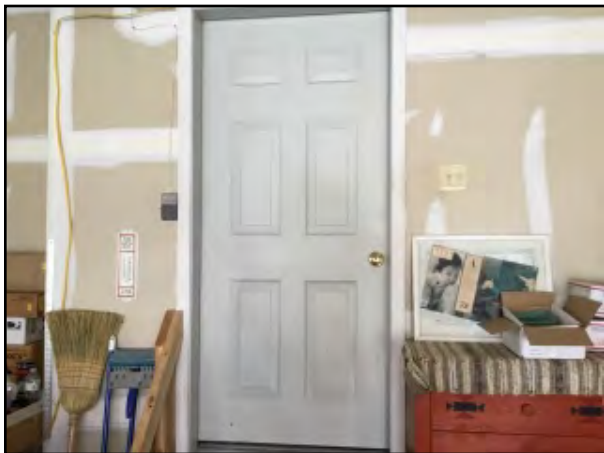
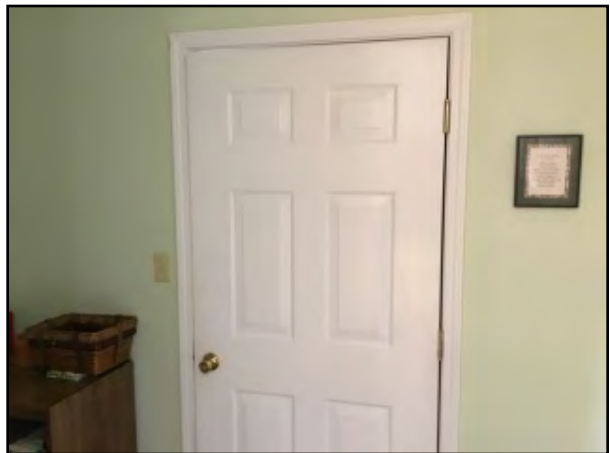
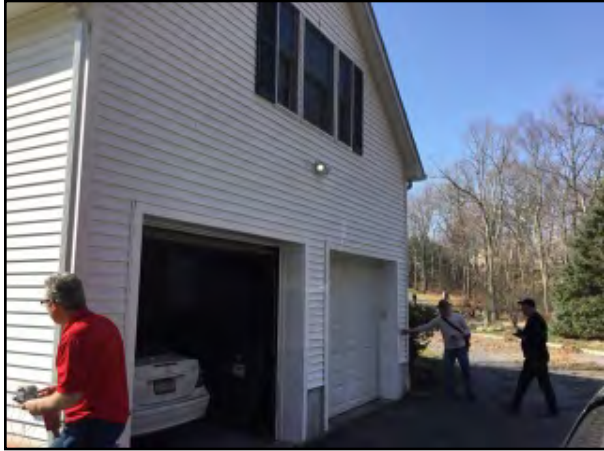
The garage is a traditional stick built building with 2x4/6 exterior walls and 2x6/8 roof rafters. The structure is in good condition with no apparent signs of moisture or water leaks at the roof. The concrete slab floor was in good condition with minor settling cracks and the garage doors are maintenance free aluminum with chain driven opener on one door only. The doors opened and closed properly and the auto reverse worked properly .

The walls and ceiling were sheet rocked/concrete for fire safety purposes where necessary, and the door leading to the interior was fire rated and self closing. No major defects were noted on the day of inspection.

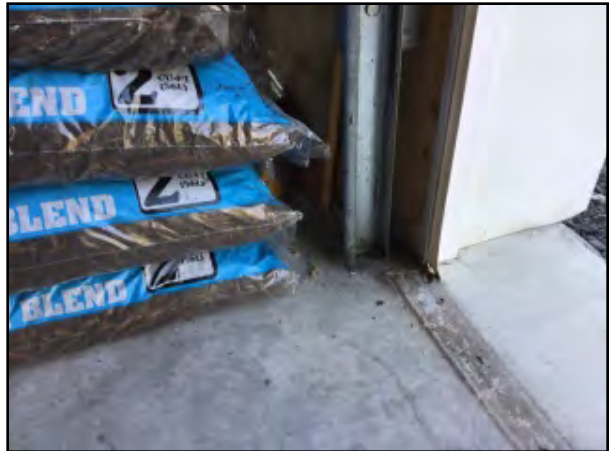
Figure 31-2

There is no photo eye attached to the garage door opener. As this is a safety issue we recommend hiring a qualified contractor to assess and repair any defects .

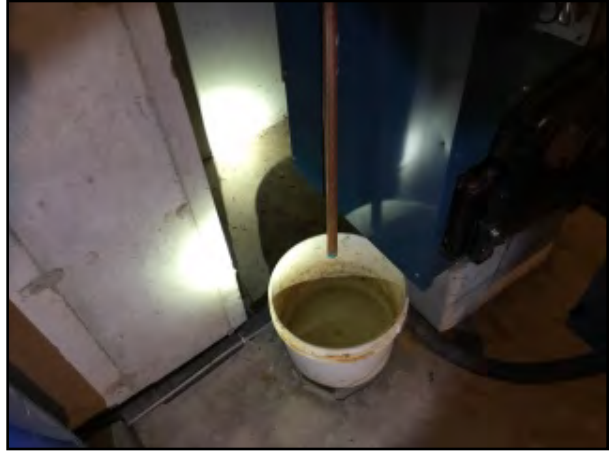
Figure 40-2

The TPRV valve was leaking and corroded. Recommend hiring a qualified contractor to assess and repair.

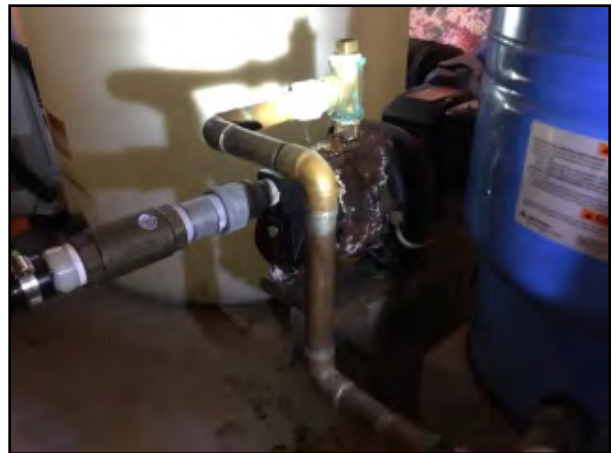
Figure 42-2

The jet pump on the water system was corroded and leaking. Recommend hiring a qualified contractor to assess and repair any defects.

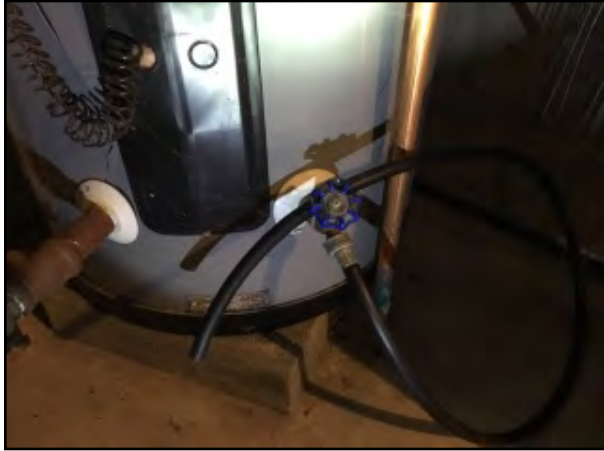
Figure 43-5

The tprv valve on the water heater was leaking and should be replaced. Recommend hiring a qualified contractor to assess and repair.

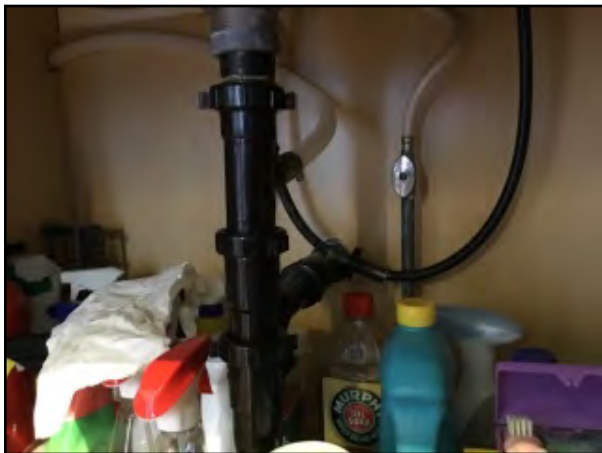
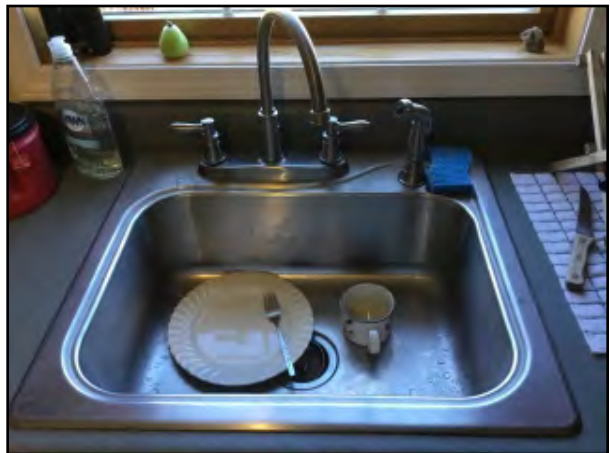
The kitchen was in working condition with no major defects noted. There were no leaks at the sink or dishwasher, and all the appliances were tested and operated properly on the date of inspection. All the cabinets and countertops were operational and secure. The range was vented by the microwave and GFCI outlets were tested and operated properly on the date of inspection.

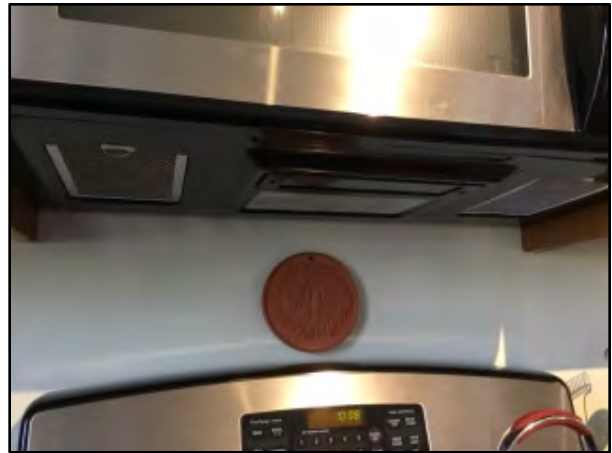
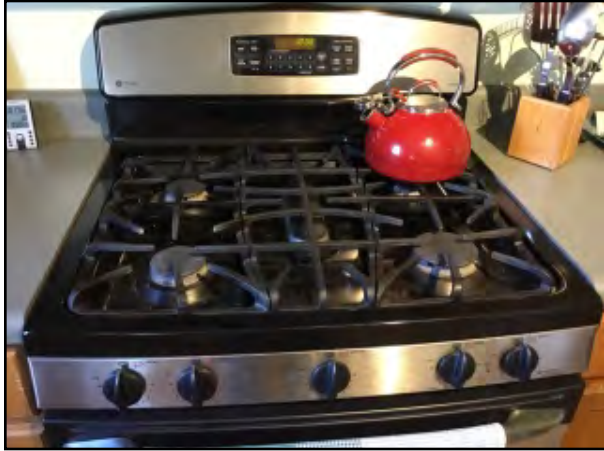
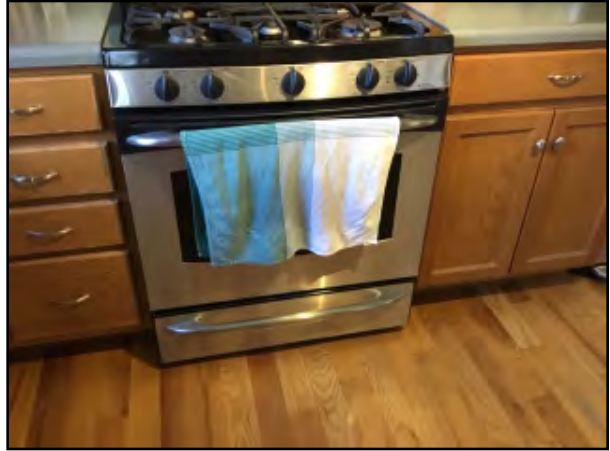
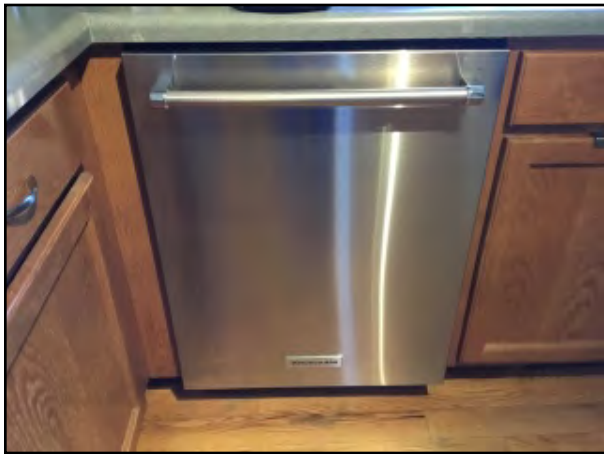
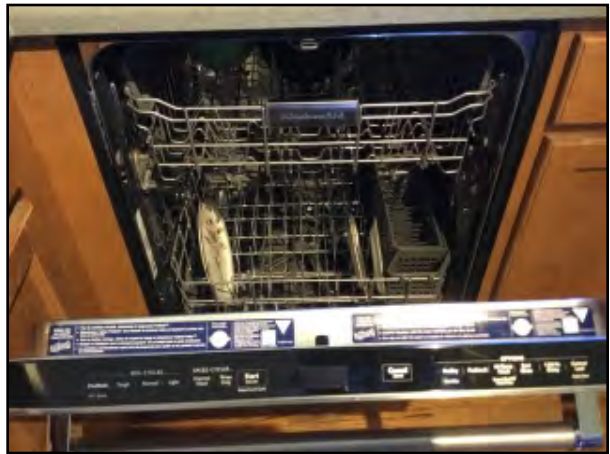
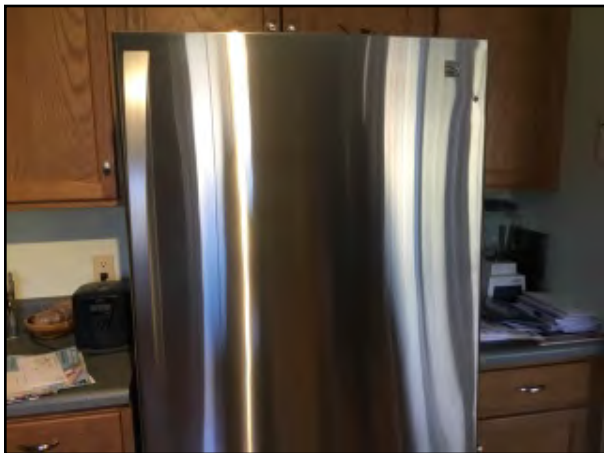
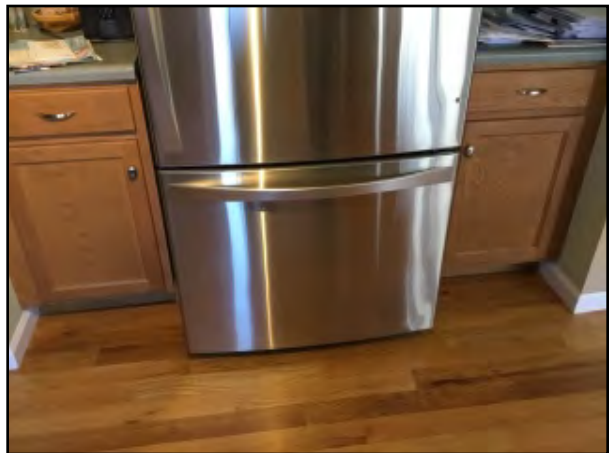
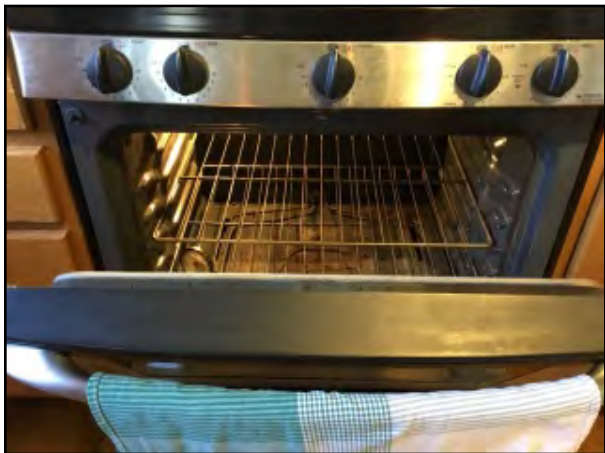
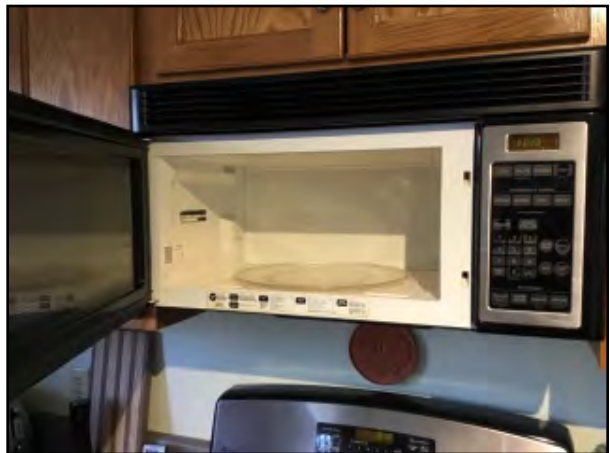
All the appliances were tested and were in working condition. The stove was vented by a range hood exhaust and operated properly. The sink is a single unit in good condition with no leaks noted.

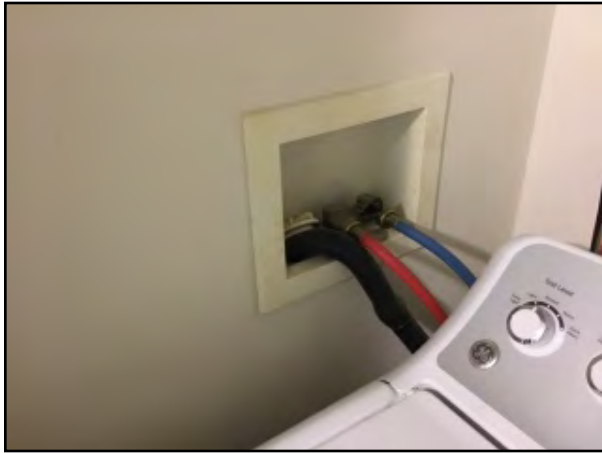
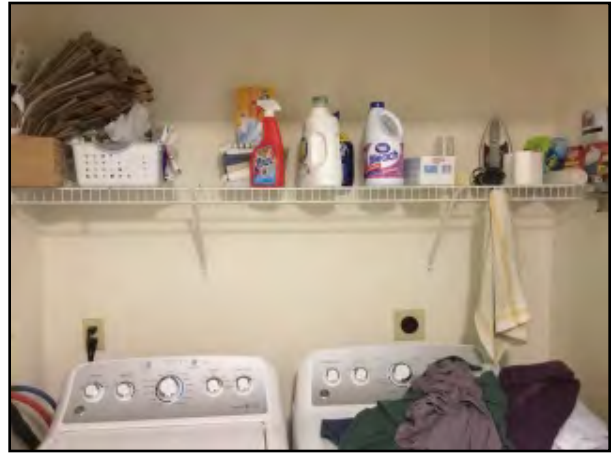
The outlet in the laundry area was not a GFCI outlet and is a safety hazard as it is directly below/next to the water supply lines. Recommend hiring a licensed electrician to replace the existing outlet with a GFCI outlet as necessary.

The exhaust hose for the dryer is a ribbed hose, not solid metal wall which is recommended for fire safety purposes. The current hose (ribbed wall) has a tendency to collect lint which is a fire hazard. Recommend hiring a qualified contractor to assess and repair as necessary.

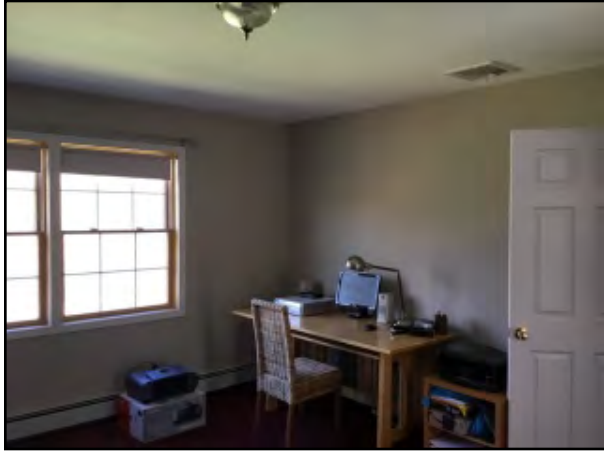
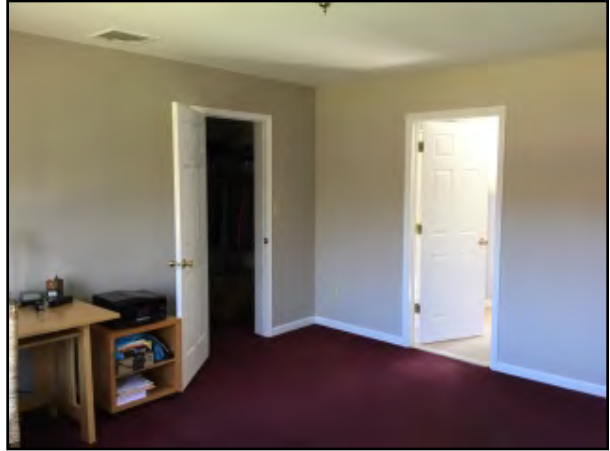
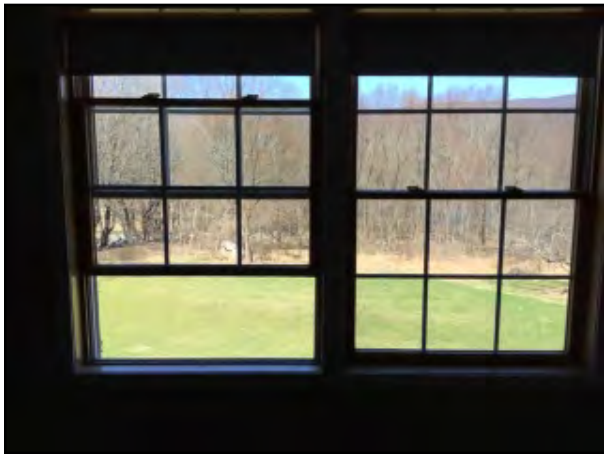
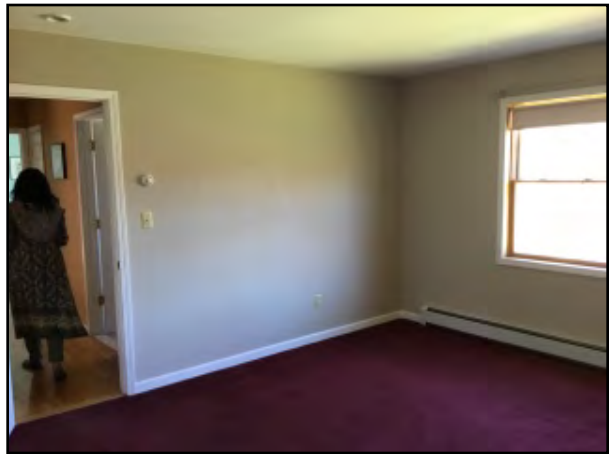
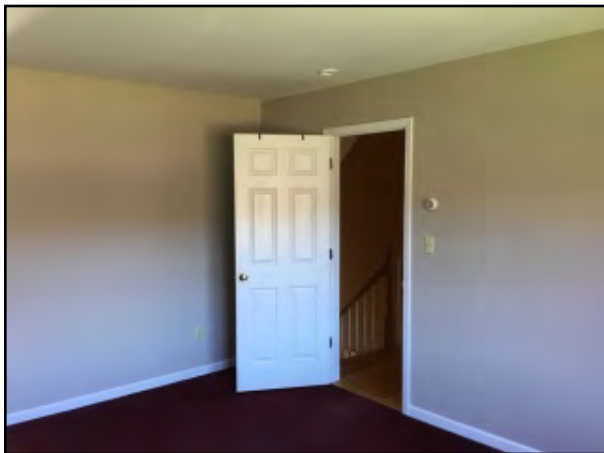
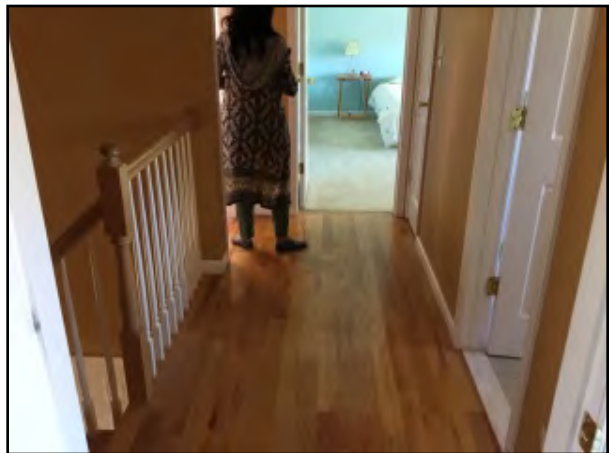
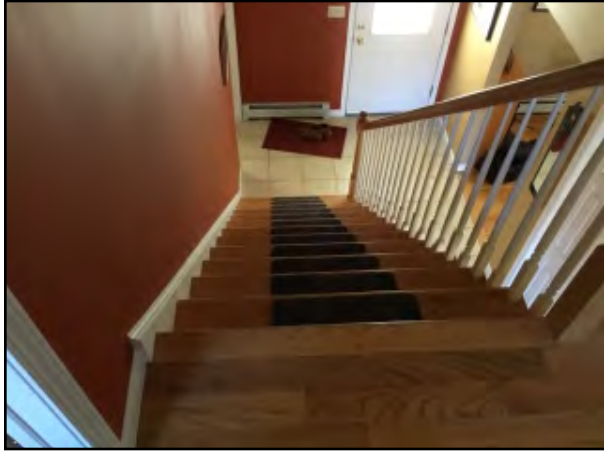
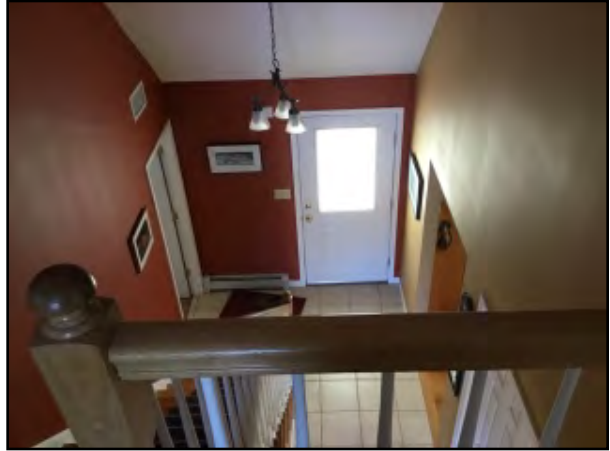
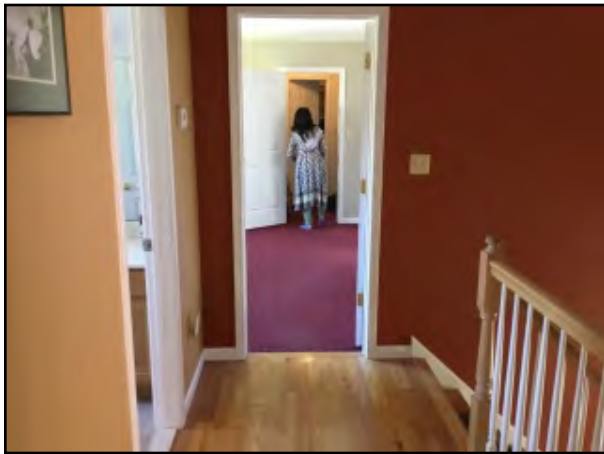
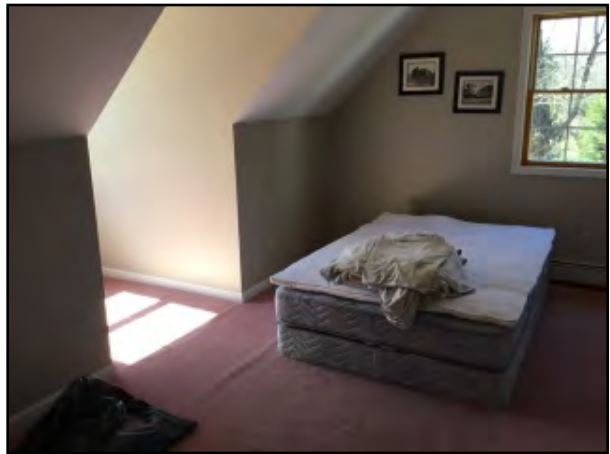
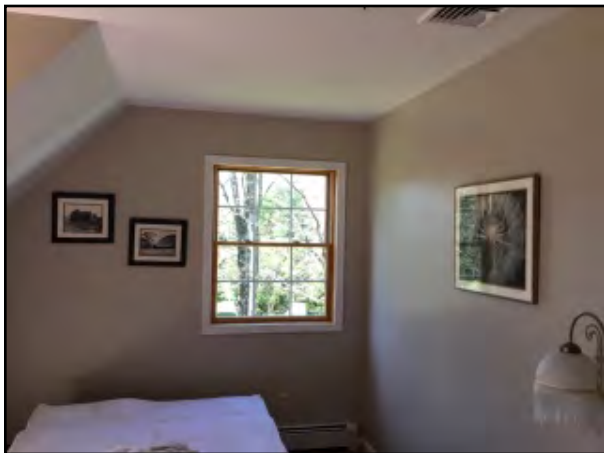
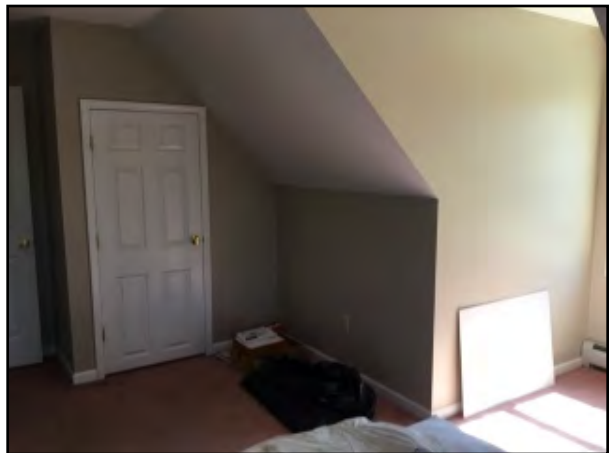
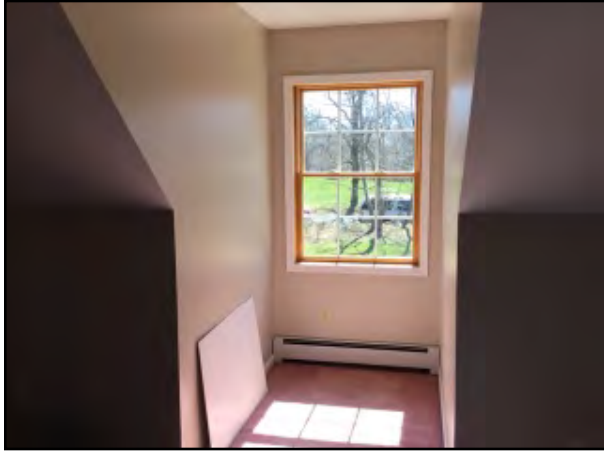
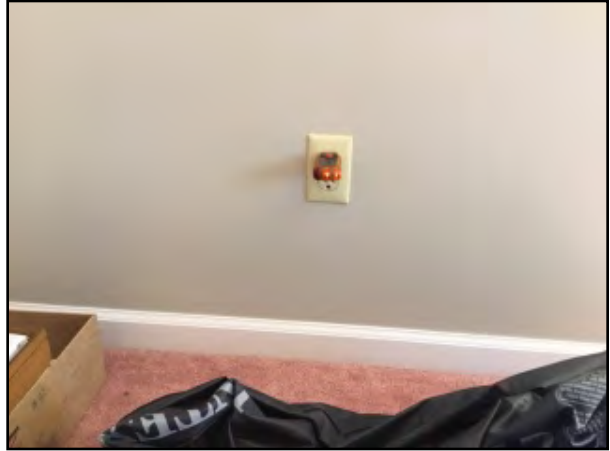
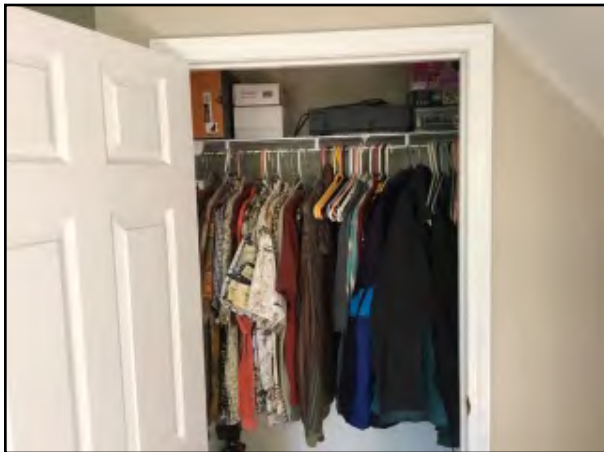
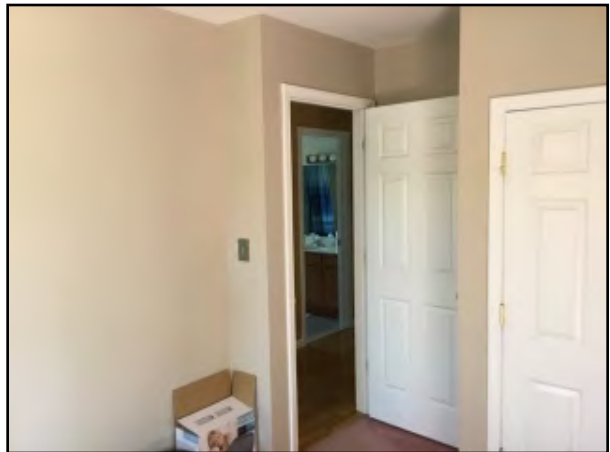
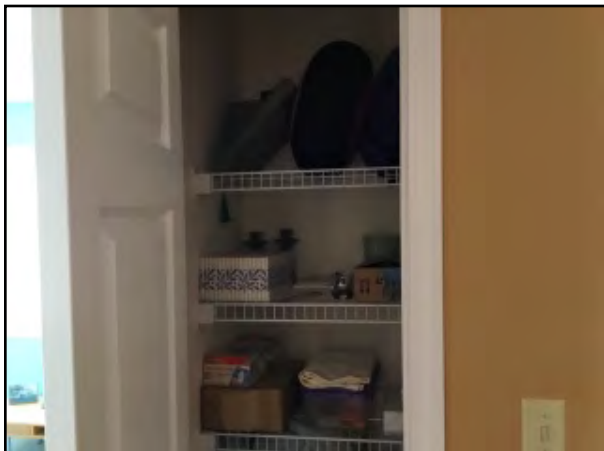
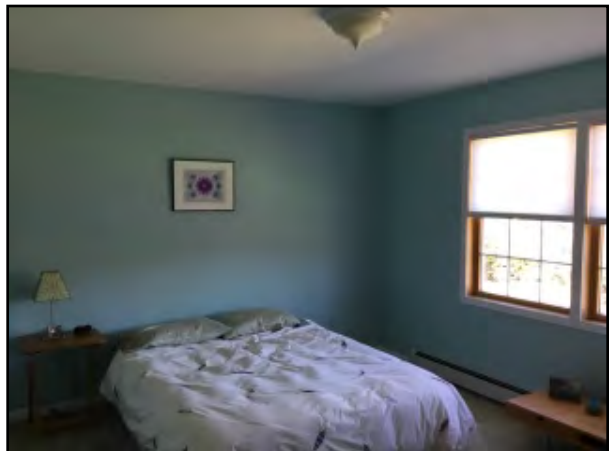
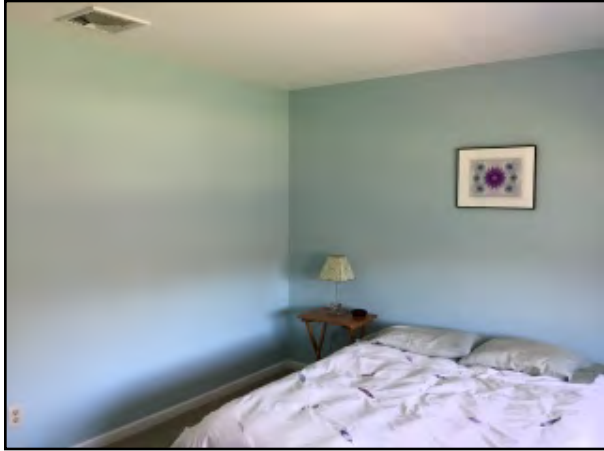
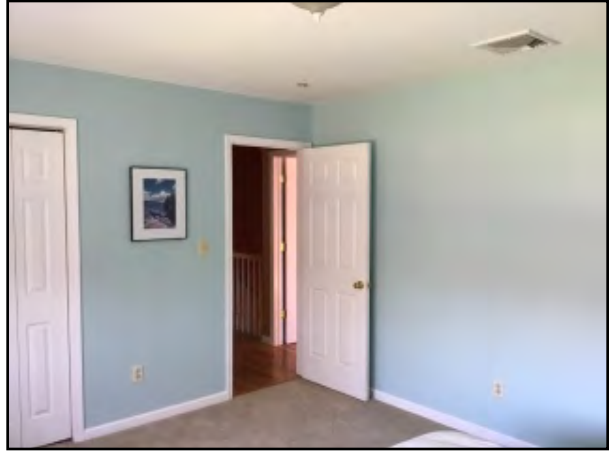
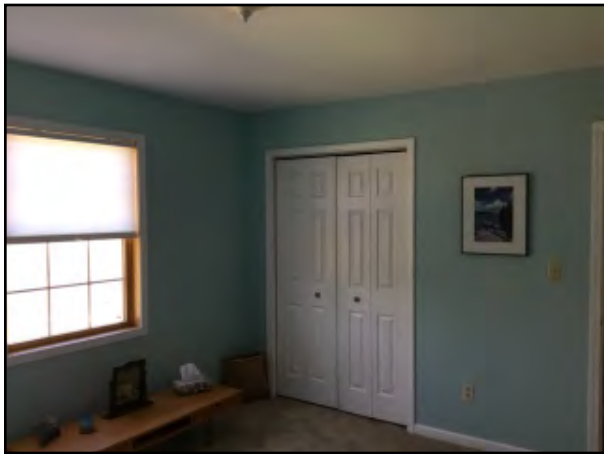
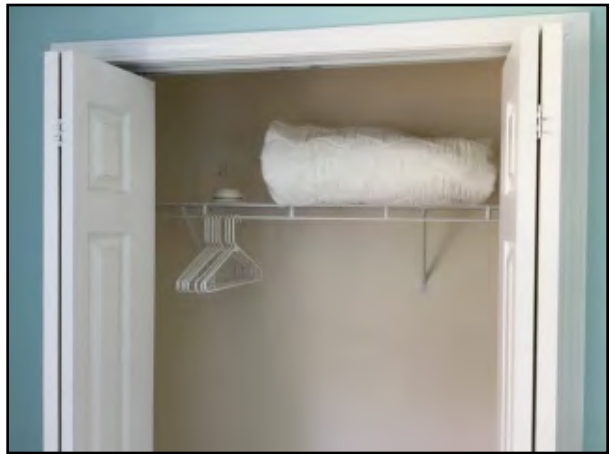
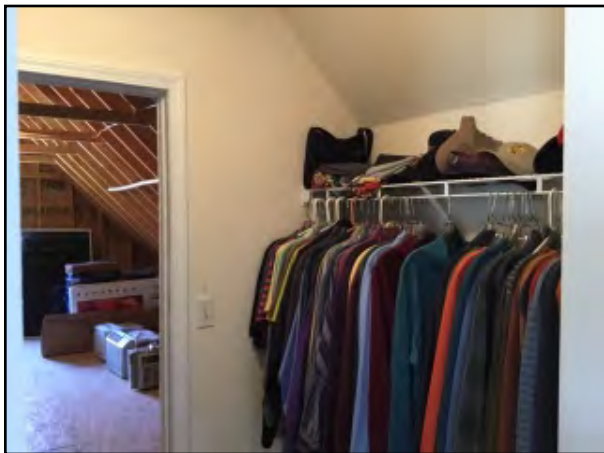
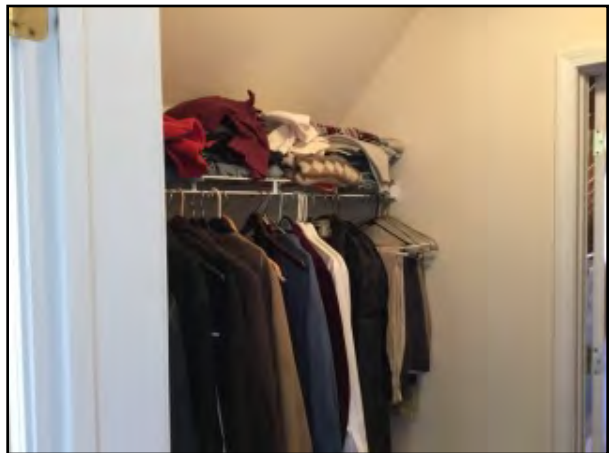
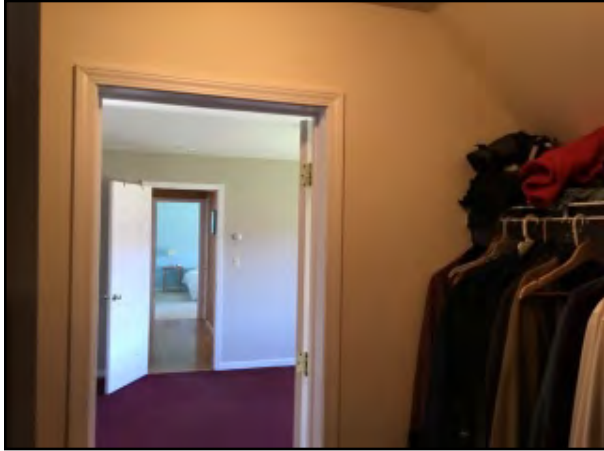
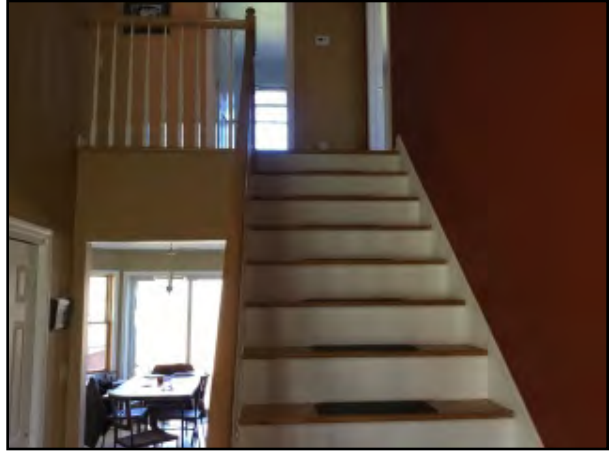
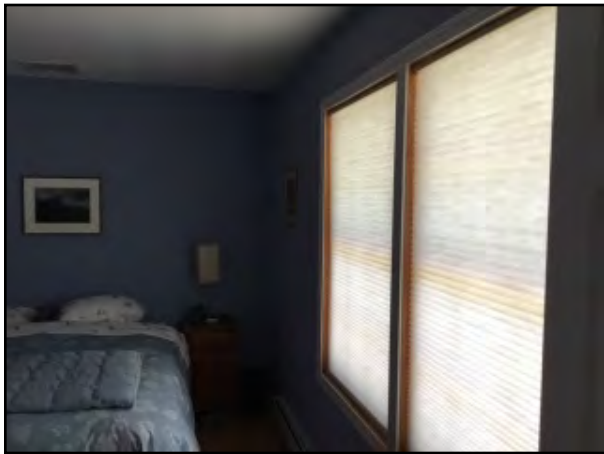
The interior was in overall good condition with no major defects noted. All floor surfaces were in good condition and the majority of the electrical outlets were three-pronged and grounded properly. There were no major cracks or holes in the walls or ceilings, and the floors were level with minimal bounce. Windows were tested randomly and operated properly.

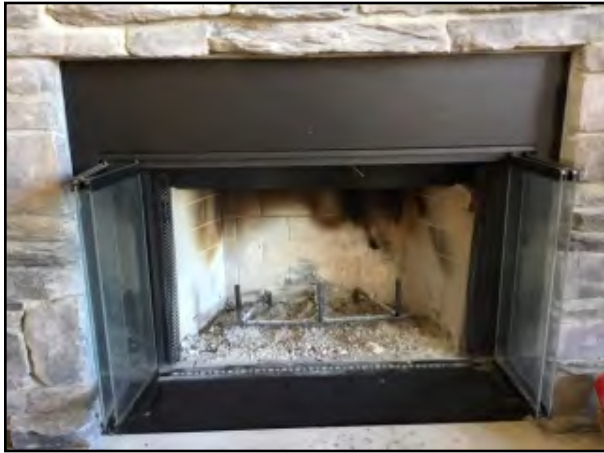
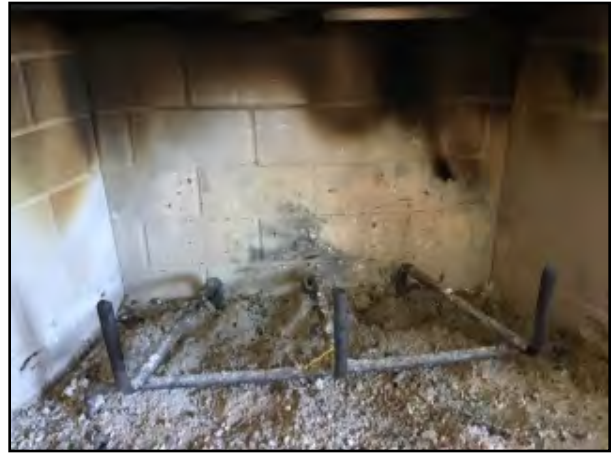
The manufactured fireplace was in good condition with no defects noted. The damper controls were tested and operated properly on the day of inspection. It is ALWAYS recommended to have the flues inspected and cleaned prior to use.

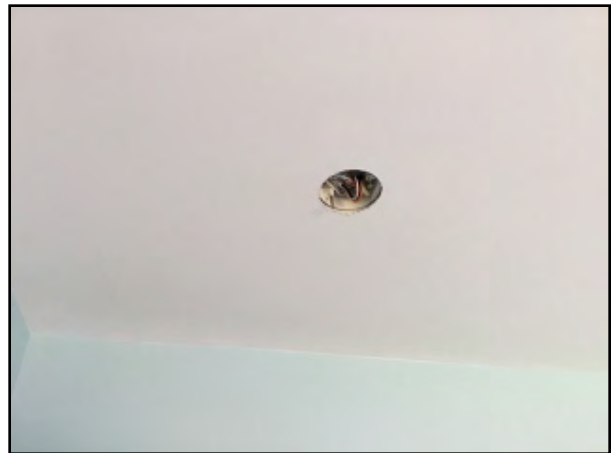
Figure 55-2

There are two bedrooms upstairs that have missing smoke alarms. As this is a safety issue it is recommended to replace them as soon as possible.

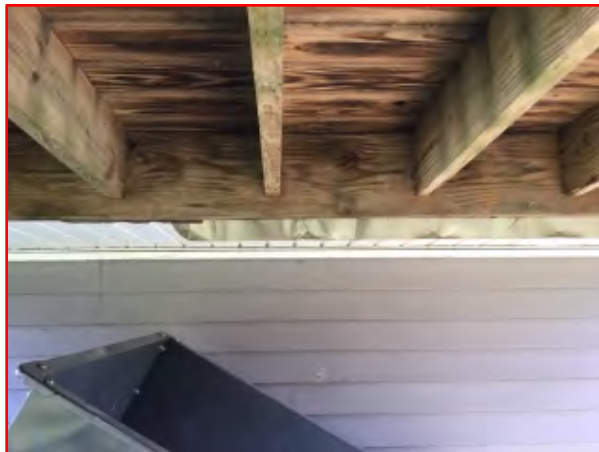
Figure 15-2

1) There are no bolts or joist hangers on the deck. Recommend hiring a qualified contractor to assess and repair.
