Residential Inspection Report

123 Everywhere St.

Anyplace , USA 55555

Inspection Date Mon, Nov 2 2015 at 11:00 AM

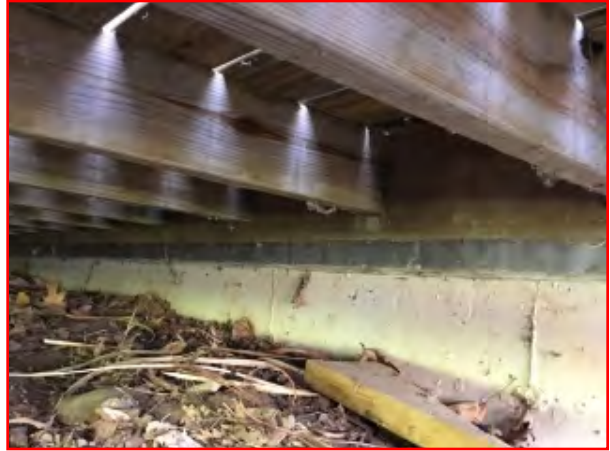
Figure 17-2

2) There are no bolts or joist hangers on the front porch. Recommend hiring a qualified contractor to assess and repair.

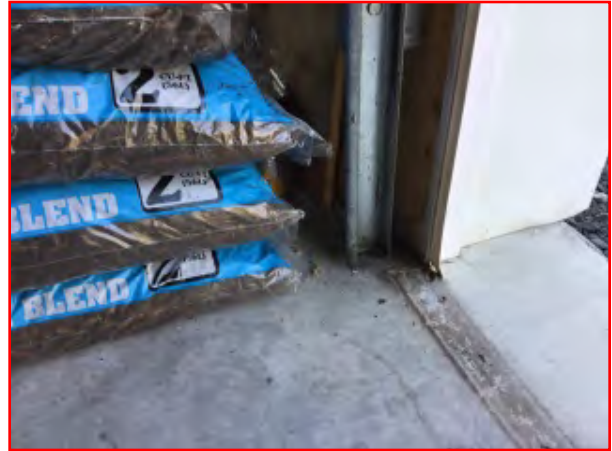
Figure 31-2

4) There is no photo eye attached to the garage door opener. As this is a safety issue we recommend hiring a qualified contractor to assess and repair any defects .

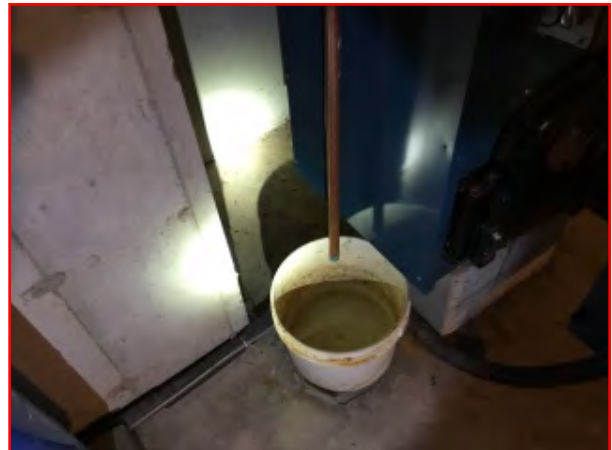
Figure 40-2

5) The TPRV valve was leaking and corroded. Recommend hiring a qualified contractor to assess and repair.

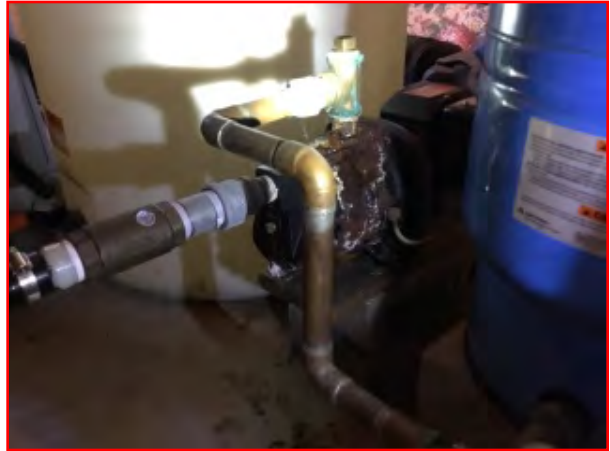
Figure 42-2

6) The jet pump on the water system was corroded and leaking. Recommend hiring a qualified contractor to assess and repair any defects.

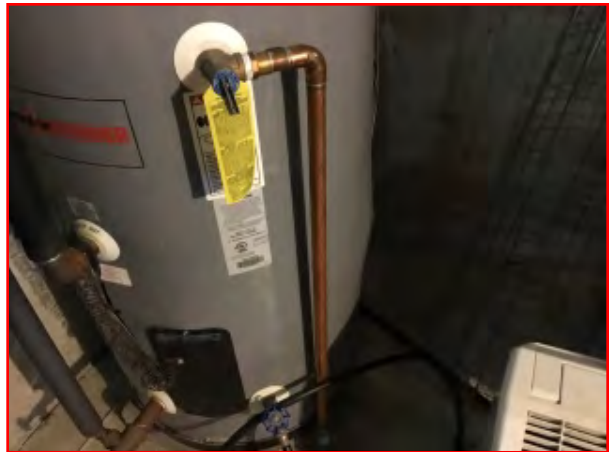
Figure 44-2

7) The tprv valve on the water heater was leaking and should be replaced. Recommend hiring a qualified contractor to assess and repair.

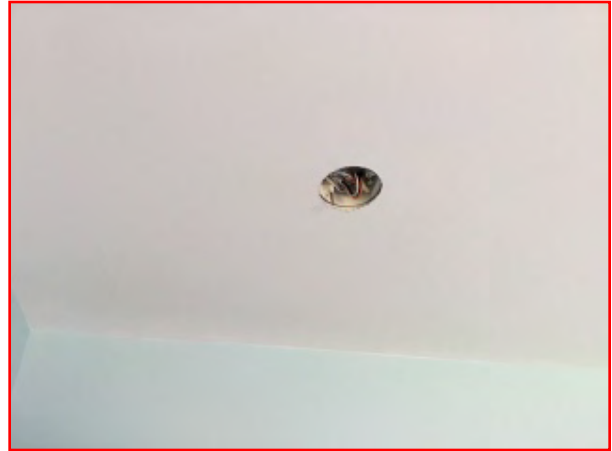
Figure 55-2

10) There are two bedrooms upstairs that have missing smoke alarms. As this is a safety issue it is recommended to replace them as soon as possible.
